Rowenna Wood / Edward Davis
On behalf of Purcell ®
St Mary's Hall, Rawstorn Road, Colchester, Essex CO3 3JH
rowenna.wood@purcelluk.com
www.purcelluk.com

INGATESTONE, ESSEX: HIGH STREET VISUAL AUDIT

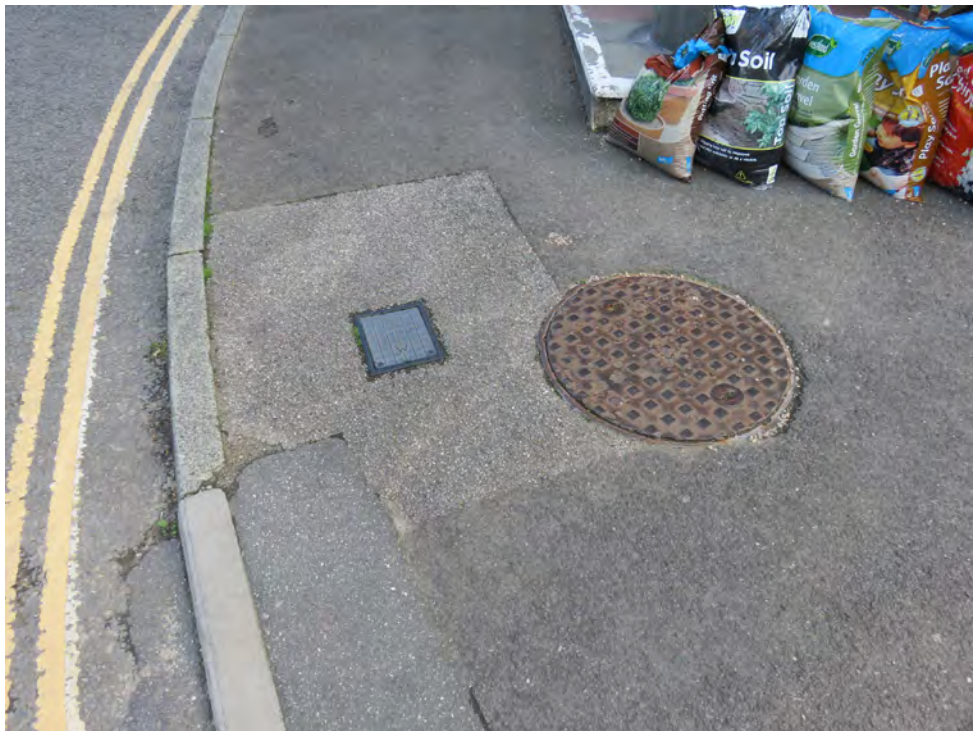
Damaged curb and patched repair to walkway in Market Square

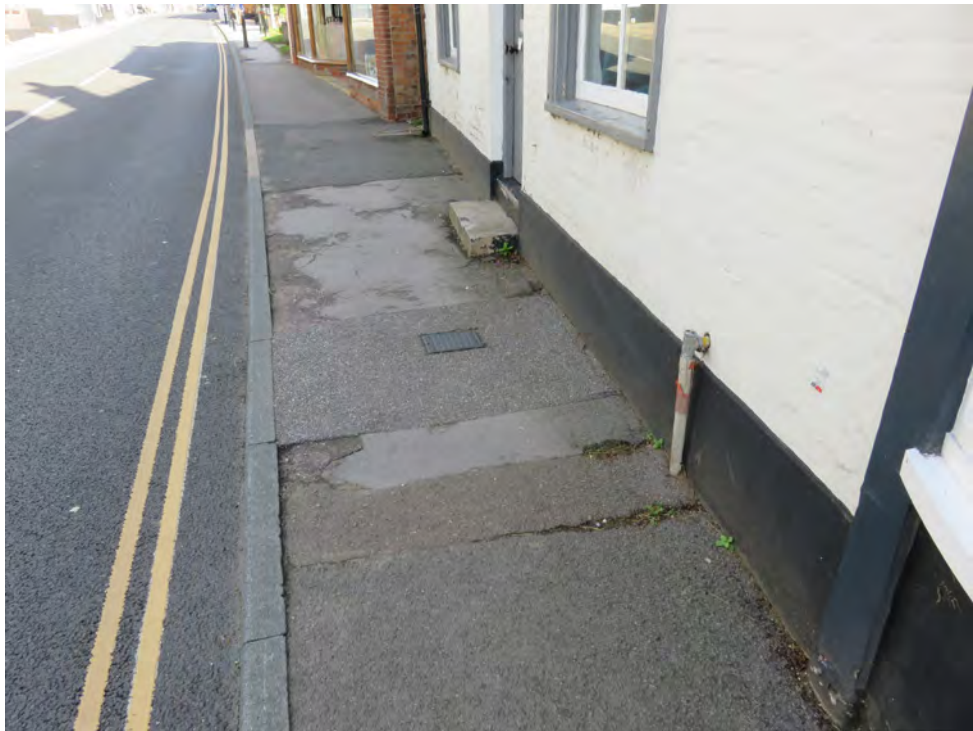
The pavement surface generally is in poor condition as a result of being repeatedly dug up for service trenching so that most of the pavements have a patchwork appearance. In a few isolated areas, the joints are deteriorating between different surfaces but the main cause of the pavement surface breaking up is caused by vehicles mounting the pavement and causing the pavement surface to break up near the kerb stones.

Varous pathces and repairs on deteriorating pavement outside 41-43 High Street

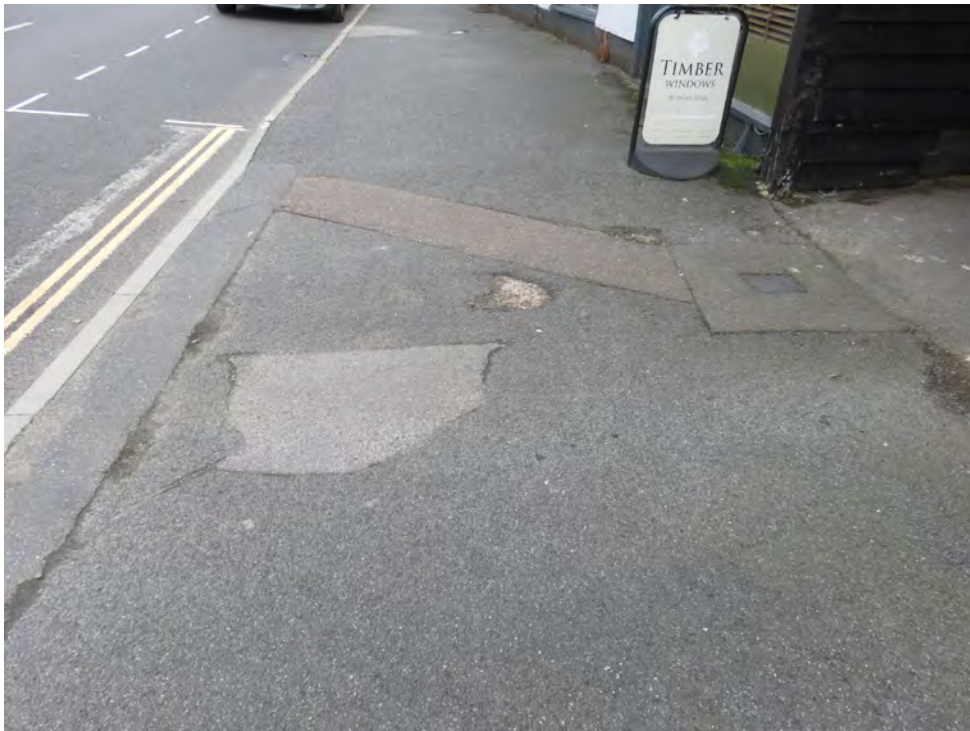
Varous patches and repairs on deteriorating pavement outside 41-43 High Street

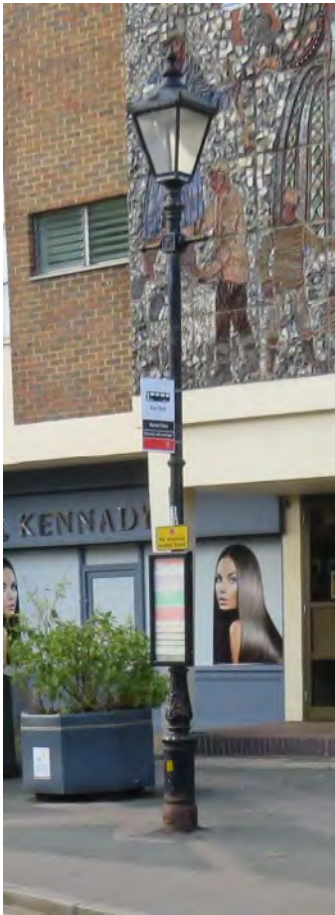
In the Square and going up the Market Place are street lamps that appear to be late nineteenth or early twentieth century cast iron street lamps with square lanterns made by DW Windsor of Hertfordshire. These are rusting at the bases and need maintenance works.

Historic cast iron lamppost in the Square

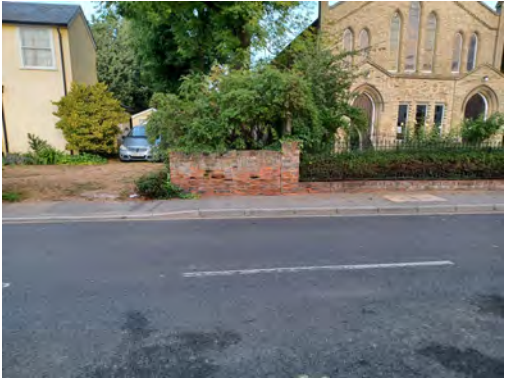
| BUILDING / STRUCTURE ELEMENT | BRIEF DESCRIPTION | BUILDING DESIGNATION | CONDITION (INCLUDING IF DISUSED) | CONTRIBUTION TO THE CA (CAA) | OBSERVATIONS / RECOMMENDATIONS | IMAGE |
|---|--|---|--|---|---|---|
| Front wall of I24 | <ul style="list-style-type: none">Red brick, Flemish bond, c.1 metre | None | Poor | 4 | Bricks delaminated and corroding due to cementitious mortar. Wall should be repointed and the missing or badly damaged bricks replaced. | |

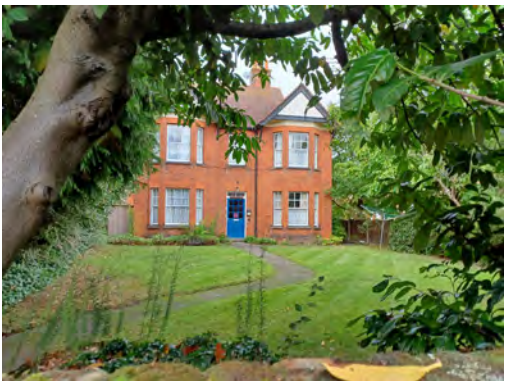
| BUILDING / STRUCTURE ELEMENT | BRIEF DESCRIPTION | BUILDING DESIGNATION | CONDITION (INCLUDING IF DISUSED) | CONTRIBUTION TO THE CA (CAA) | OBSERVATIONS / RECOMMENDATIONS | IMAGE |
|---|--|---|--|---|---|---|
| The Manse | <ul style="list-style-type: none">Nineteenth century redbrick house with plain tiled roof, two-storeys.Double sets of gable-ended bay windows either side of front door.Mostly hidden by red brick.Flemish bond wall of varying heights and large bushes and trees. | None | Good | 4 | Boundary wall requires repointing along lower half. | |

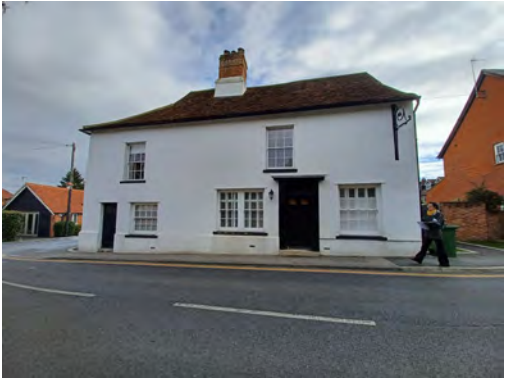
| BUILDING / STRUCTURE ELEMENT | BRIEF DESCRIPTION | BUILDING DESIGNATION | CONDITION (INCLUDING IF DISUSED) | CONTRIBUTION TO THE CA (CAA) | OBSERVATIONS / RECOMMENDATIONS | IMAGE |
|---|---|---|--|--|--|---|
| Former PH (The Crown Inn) | <ul style="list-style-type: none">• Timber framed now plastered.• Fifteenth century, altered in nineteenth century.• Two-storeys and attic level visible from south-west.• Single stack and plain tiled roof.• Lower, two-storey extension at rear and single-storey lean-to and brick stack visible from north-east.• Street elevation has five horned sash windows and two, six-panelled timber doors. | Grade II | Fair Disused | 5 | Consider using the empty bracket for a sign. | |

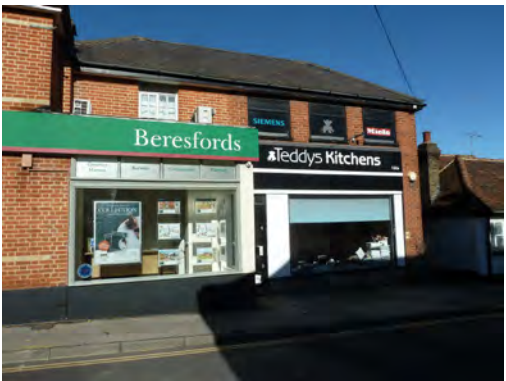
| BUILDING / STRUCTURE ELEMENT | BRIEF DESCRIPTION | BUILDING DESIGNATION | CONDITION (INCLUDING IF DISUSED) | CONTRIBUTION TO THE CA (CAA) | OBSERVATIONS / RECOMMENDATIONS | IMAGE |
|---|---|---|--|--|--|---|
| 122a, Teddy's Kitchens | <ul style="list-style-type: none">• Twentieth century red brick Flemish bond and grey slate.• Two-storeys partially boarded up.• Large shopfront window. | None | Disused Some action needed | 4 (Note this seems too high given its current appearance) | Currently disused and slightly dilapidated with rubbish very visible in the shopfront. | |

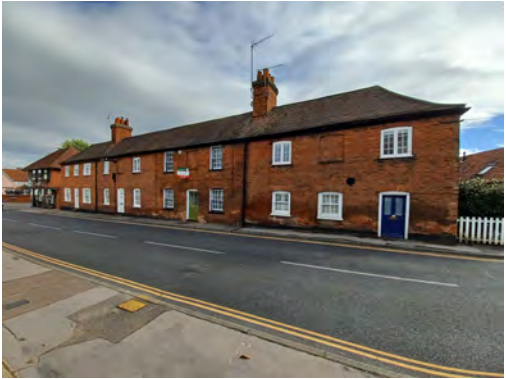
| BUILDING / STRUCTURE ELEMENT | BRIEF DESCRIPTION | BUILDING DESIGNATION | CONDITION (INCLUDING IF DISUSED) | CONTRIBUTION TO THE CA (CAA) | OBSERVATIONS / RECOMMENDATIONS | IMAGE |
|---|--|---|--|---|--|---|
| 59, 61, 63 and 65 | <ul style="list-style-type: none">Two-storey red brick Flemish bond range of four terraced houses sharing two central stacks.No.59 has three upper floor windows and two at lower floor.Nos.61, 63 and 65 have two upper floor and a recessed bluff window. | None | Good | 4 | <p>Replace the wall mounted street light and remove, if possible, the junction box and cabling.</p> <p>Remove aerials if redundant.</p> | |

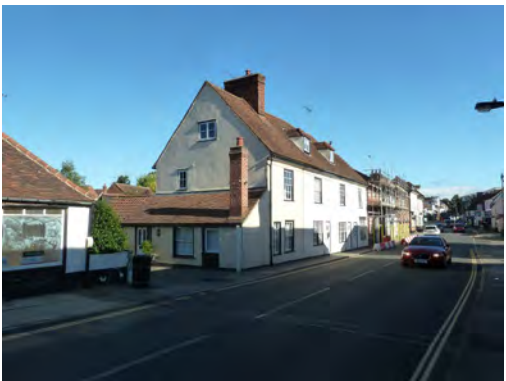
| BUILDING / STRUCTURE ELEMENT | BRIEF DESCRIPTION | BUILDING DESIGNATION | CONDITION (INCLUDING IF DISUSED) | CONTRIBUTION TO THE CA (CAA) | OBSERVATIONS / RECOMMENDATIONS | IMAGE |
|---|--|---|--|---|--|---|
| 112, 114, 116 and 118 | <ul style="list-style-type: none">Originally one house.Seventeenth or eighteenth century, altered in the nineteenth. Timber framed.Two-storey range with two attic gabled dormers.Possibly former timber framed, with single storey lean-to on to the south-west with steel support.Un-horned sash windows.Three stable doors on front elevation. | Grade II | | 5 | <p>Is the steel support able to be disguised?</p> | |

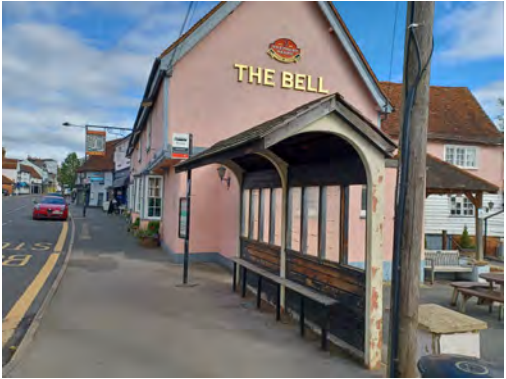
| BUILDING / STRUCTURE ELEMENT | BRIEF DESCRIPTION | BUILDING DESIGNATION | CONDITION (INCLUDING IF DISUSED) | CONTRIBUTION TO THE CA (CAA) | OBSERVATIONS / RECOMMENDATIONS | IMAGE |
|---|---|---|--|---|---|---|
| Bus Stop | <ul style="list-style-type: none">Timber.Two bays between three curved posts supporting a tiled roof. | None | Good | 4 | Redecorate the structure. | |

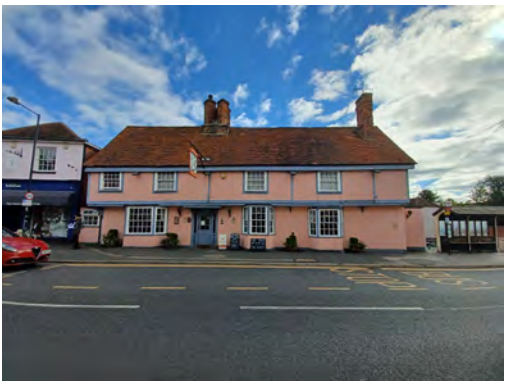
| BUILDING / STRUCTURE ELEMENT | BRIEF DESCRIPTION | BUILDING DESIGNATION | CONDITION (INCLUDING IF DISUSED) | CONTRIBUTION TO THE CA (CAA) | OBSERVATIONS / RECOMMENDATIONS | IMAGE |
|---|---|---|--|---|---|---|
| The Bell Inn | <ul style="list-style-type: none">Working Public House.Early/late fifteenth century, with additions in early seventeenth and nineteenth centuries.Large two-storey gable ended timber framed building with first floor jettied above three bay windows, plastered and weatherboarded.Twentieth century clay tiled roof.T-plan with principal long range along the High Street.Central seventeenth century brick stack of four decorated chimneys.A further brick stack at the south-west end. | Grade II | Good | 5 | Moss on the roof tiles | |

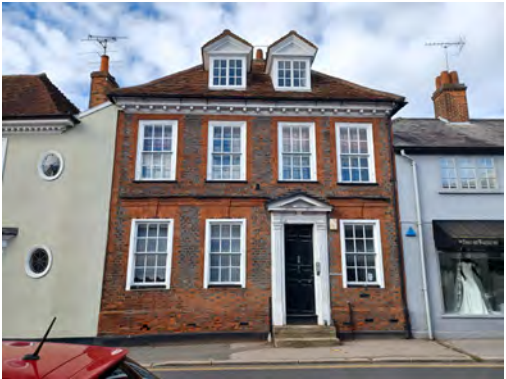
| BUILDING / STRUCTURE ELEMENT | BRIEF DESCRIPTION | BUILDING DESIGNATION | CONDITION (INCLUDING IF DISUSED) | CONTRIBUTION TO THE CA (CAA) | OBSERVATIONS / RECOMMENDATIONS | IMAGE |
|---|--|---|--|---|---|---|
| 98 | <ul style="list-style-type: none">• Early eighteenth century, extended nineteenth/twentieth century.• Two-storeys with attic and two gabled dormers.• Timber-framed with façade of blue bricks in header bond with red brick dressings (some in Flemish bond).• Roofed in handmade red clay tiles.• Modillion cornice.• Classical timber door casement. | Grade II* | | 5 | Cementitious mortar pointing. Brick repairs urgently needed at lower level. Tidy (and paint) loose wires. Remove aerial if redundant. | |

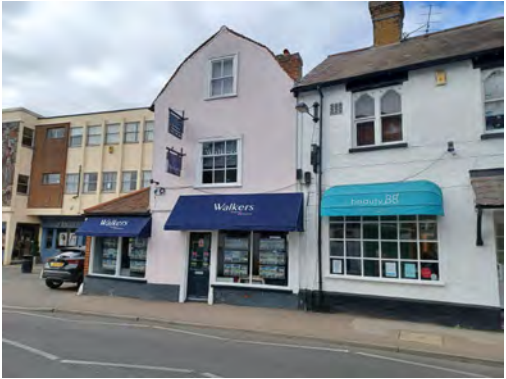
| BUILDING / STRUCTURE ELEMENT | BRIEF DESCRIPTION | BUILDING DESIGNATION | CONDITION (INCLUDING IF DISUSED) | CONTRIBUTION TO THE CA (CAA) | OBSERVATIONS / RECOMMENDATIONS | IMAGE |
|---|--|---|--|---|--|---|
| 90A, Walkers | <ul style="list-style-type: none">Three-storeys perpendicular to the road, gambrel gable ended.Probably timber framed and plastered with a one-storey twentieth century lean-to on the market place side, of red brick Flemish bond.Two large ground floor shop windows on the high elevation, one on the market place elevation, each with awnings. | None | | 4 | Remove any redundant cables and securely fix and paint the remainder. | |

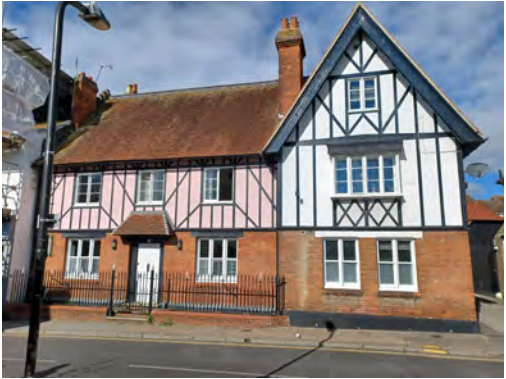
| BUILDING / STRUCTURE ELEMENT | BRIEF DESCRIPTION | BUILDING DESIGNATION | CONDITION (INCLUDING IF DISUSED) | CONTRIBUTION TO THE CA (CAA) | OBSERVATIONS / RECOMMENDATIONS | IMAGE |
|---|---|---|--|---|---|---|
| 78 | <ul style="list-style-type: none">Appears to be an older building with nineteenth and twentieth century embellishments.Two-storeys and an attic floor; red rick English bond on ground floor; timber and plaster/pebble dash on upper floors.Roofed in red clay tiles.T-shaped plan with right gable end facing the churchyard containing a led roofed timber oriel window.Left end has original brick stepped gabling.Left range has a twentieth/twenty-first century dwarf brick wall with metal railing around. | None | | 4 | <p>Replace the railings with higher quality railings when the opportunity arises.</p> <p>Tidy wiring.</p> <p>Relocate satellite dish.</p> | |

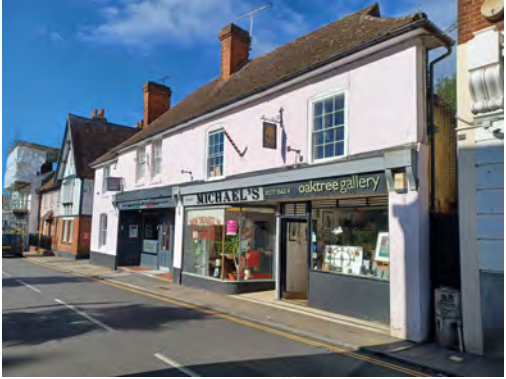
| BUILDING / STRUCTURE ELEMENT | BRIEF DESCRIPTION | BUILDING DESIGNATION | CONDITION (INCLUDING IF DISUSED) | CONTRIBUTION TO THE CA (CAA) | OBSERVATIONS / RECOMMENDATIONS | IMAGE |
|---|---|---|--|---|---|---|
| 76 | <ul style="list-style-type: none">Former House now three shops.Fifteenth century altered and added to in eighteenth, nineteenth and twentieth centuries.Two-storeys.Timber framed and partly of brick.First floor is brick façade.First floor of four sashes of 6+6 lights.Ground floor; two recessed shop fronts and a curved floor to ceiling glazed window.South-west extended range of one bay and an upper and lower sash window of 3+3 lights. | Grade II | | 5 | <p>Replace step with better matching stone.</p> <p>Remove alarm box from shopfront console bracket.</p> | |

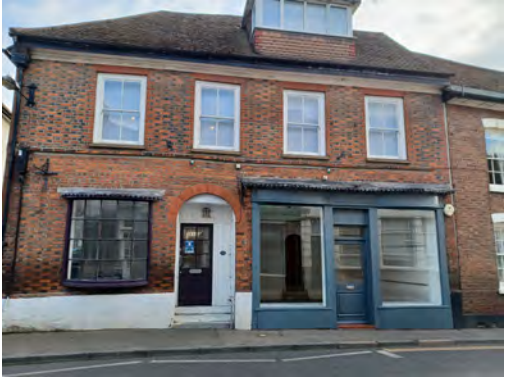
| BUILDING / STRUCTURE ELEMENT | BRIEF DESCRIPTION | BUILDING DESIGNATION | CONDITION (INCLUDING IF DISUSED) | CONTRIBUTION TO THE CA (CAA) | OBSERVATIONS / RECOMMENDATIONS | IMAGE |
|---|---|---|--|---|---|---|
| 25, Bella Blake | <ul style="list-style-type: none">Former house now two shops.Two-storeys with twentieth century attic dormer.Red and blue bricks Flemish bond and roofed with concrete tiles.Ground floor twentieth century bow window of 20 lights on left, at right, shopfront with central half glazed door.Recessed doorway to left of middle with semi-circle arch of gauged brick.Up two stone steps a twentieth century half-glazed door. | Grade II | | 5 | <p>Add sign into sign bracket.</p> <p>Remove redundant wiring and neatly refix required wiring.</p> <p>Replace uPVC windows in the dormer with in-keeping painted timber windows.</p> | |

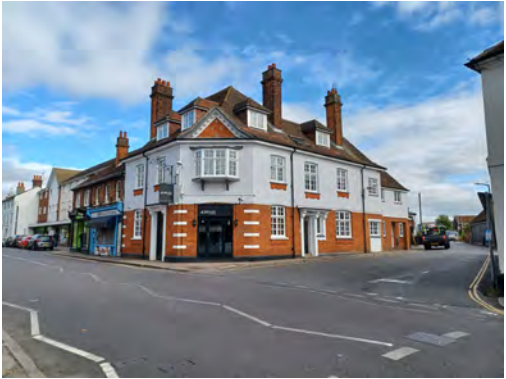
| BUILDING / STRUCTURE ELEMENT | BRIEF DESCRIPTION | BUILDING DESIGNATION | CONDITION (INCLUDING IF DISUSED) | CONTRIBUTION TO THE CA (CAA) | OBSERVATIONS / RECOMMENDATIONS | IMAGE |
|---|---|---|--|---|---|---|
| Library Bar and Restaurant. | <ul style="list-style-type: none">Two-storey brick building with various hipped and gabled attic dormers.The whole building with a canted corner which has an oriel window of 40 lights above a glazed doorway. | None | Good | 4 | <p>Reuse historic sign bracket and remove the modern one.</p> | |

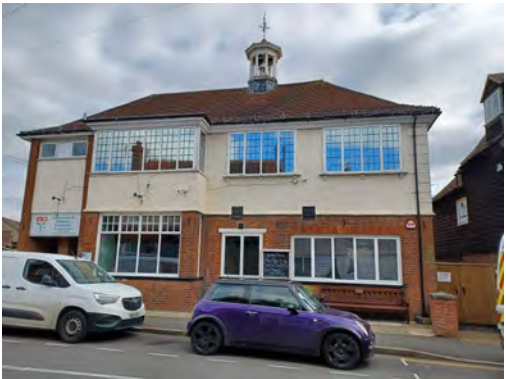
| BUILDING / STRUCTURE ELEMENT | BRIEF DESCRIPTION | BUILDING DESIGNATION | CONDITION (INCLUDING IF DISUSED) | CONTRIBUTION TO THE CA (CAA) | OBSERVATIONS / RECOMMENDATIONS | IMAGE |
|---|---|---|--|---|--|---|
| 7, Ingatestone and Fryerning Community Association | <ul style="list-style-type: none">Main range by the High Street: Rectangular plan building (late/early nineteenth/twentieth century), in red brick English bond and plaster.A plain tiled hipped roof with a cupola and weathervane in the centre towards the south-west end.Seemingly of four bays, the second from the left being a two-storey bay.The fenestration on the upper floor is lead lined and two windows have decorative timber brackets under the sills.Plaster or pebbledash on the western corner has rusticated coinings. | None | | 4 | <p>Replace windows, particularly the large blank lower floor ones and first floor windows over the door.</p> <p>Remove fairy lights.</p> <p>Remove redundant cables and refix and paint the remainder.</p> | |

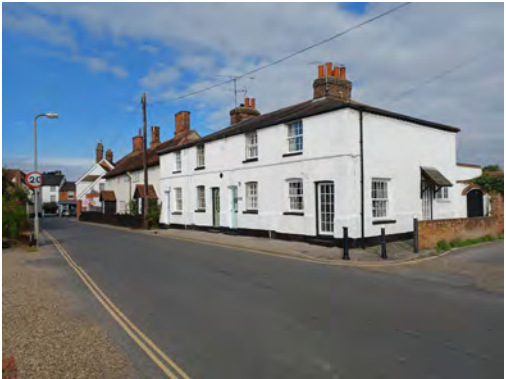
| BUILDING / STRUCTURE ELEMENT | BRIEF DESCRIPTION | BUILDING DESIGNATION | CONDITION (INCLUDING IF DISUSED) | CONTRIBUTION TO THE CA (CAA) | OBSERVATIONS / RECOMMENDATIONS | IMAGE |
|--|--|---|--|---|--|---|
| Arrol Cottages | <ul style="list-style-type: none">Terrace of four houses.Painted pebble dash, hipped roof of slate and two central brick stacks.Metre high plinth still visible around building.Each door has two steps up from the pavement.Each house has one sash window on both ground and first floor. | None | Good | 4 | Remove aerials if redundant. Remove or relocate prominent wiring if possible. | |

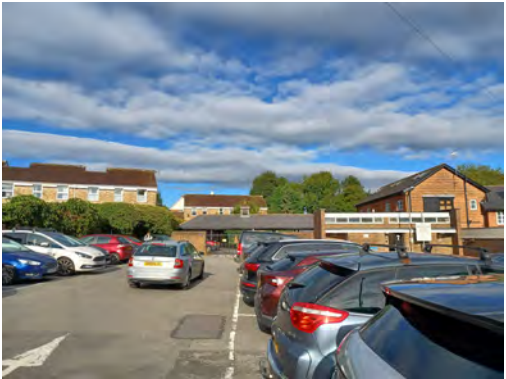
| BUILDING / STRUCTURE ELEMENT | BRIEF DESCRIPTION | BUILDING DESIGNATION | CONDITION (INCLUDING IF DISUSED) | CONTRIBUTION TO THE CA (CAA) | OBSERVATIONS / RECOMMENDATIONS | IMAGE |
|---|--|---|--|---|---|---|
| Car Park | <ul style="list-style-type: none">Tarmac car park surrounded on three sides by a wall, further private parking enclosure, public toilet block and rear range of the main market place building. | None | | 2 | Tarmac decaying in places with some small potholes and faded paint. | |

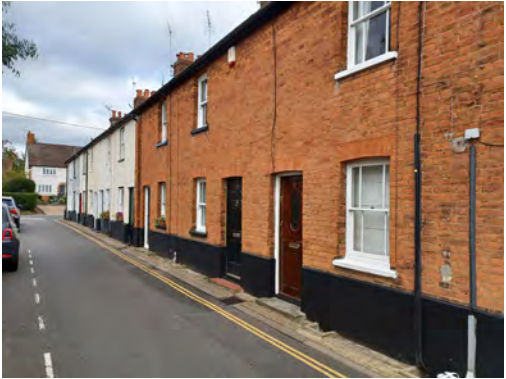
| BUILDING / STRUCTURE ELEMENT | BRIEF DESCRIPTION | BUILDING DESIGNATION | CONDITION (INCLUDING IF DISUSED) | CONTRIBUTION TO THE CA (CAA) | OBSERVATIONS / RECOMMENDATIONS | IMAGE |
|--|---|---|--|---|---|---|
| 1, 3 5, 7, 9, 11, 13, 15, 17 and 19 | <ul style="list-style-type: none">• Range of 10 terraced two-storey houses.• Four brick Flemish bond, four plastered and painted, two weatherboarded and painted.• Each with a first floor and ground floor sashed window.• One step from street to doors.• Some six panelled doors. | None | Good | 4 | <p>Remove aerials if redundant.</p> <p>Paint cables to match wall colour where facade is painted.</p> | |

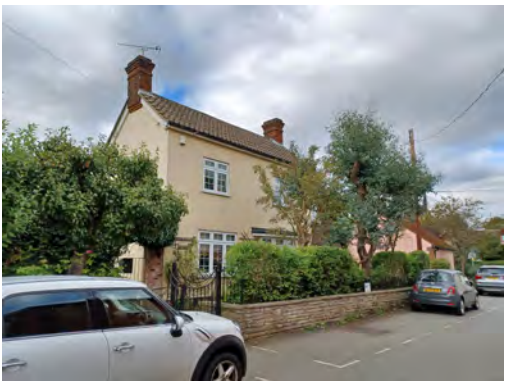
| BUILDING / STRUCTURE ELEMENT | BRIEF DESCRIPTION | BUILDING DESIGNATION | CONDITION (INCLUDING IF DISUSED) | CONTRIBUTION TO THE CA (CAA) | OBSERVATIONS / RECOMMENDATIONS | IMAGE |
|--|---|---|--|---|---|---|
| 6 | <ul style="list-style-type: none">• Two-storey brick and plastered house with large ground floor bow window.• Roofed in pantiles with brick stacks at either end on the main range with plain cornices.• Extension range connecting to the garage with garage attic conversion window of 24 lights.• L-shaped formation with a lean-to on the market place side.• Twentieth century conservatory at the rear. | None | Good | 4 | <p>Remove aerial if redundant.</p> | |

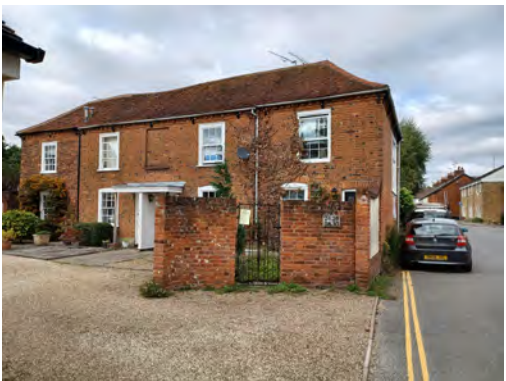
| BUILDING / STRUCTURE ELEMENT | BRIEF DESCRIPTION | BUILDING DESIGNATION | CONDITION (INCLUDING IF DISUSED) | CONTRIBUTION TO THE CA (CAA) | OBSERVATIONS / RECOMMENDATIONS | IMAGE |
|---|--|---|--|---|--|---|
| 24, 26, 28 and 30 | <ul style="list-style-type: none">Range of four red brick Flemish bond houses terraced houses.Each two-storeys with a set of sash windows of 12 lights.Central window is false.Roofed in red plain tiles. | None | Good | 4 | Remove aerial if redundant. Remove or relocate satellite dish from front elevation. | |

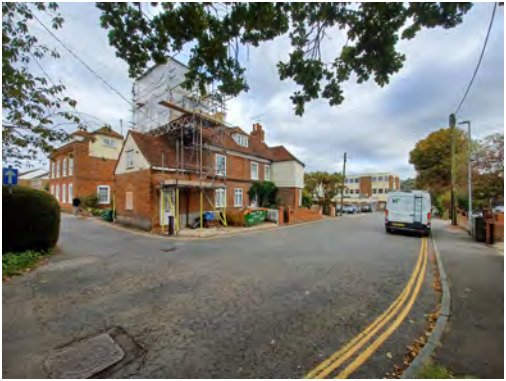
| BUILDING / STRUCTURE ELEMENT | BRIEF DESCRIPTION | BUILDING DESIGNATION | CONDITION (INCLUDING IF DISUSED) | CONTRIBUTION TO THE CA (CAA) | OBSERVATIONS / RECOMMENDATIONS | IMAGE |
|---|--|---|--|---|---|---|
| 37, 20 and 18 (Market Place) | <ul style="list-style-type: none">Two-storey house with attic dormer, now three dwellings (including former barbershop).Mix of bred brick bonds.Three surviving sash windows and one bluff window on Market Place elevation.Single-storey extension range to the north.Rear extensions of plaster and weatherboarding. | Grade II | Good | 5 | Remove aerial if redundant. | |

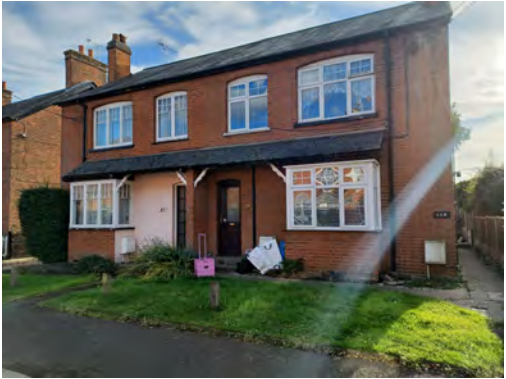
| BUILDING / STRUCTURE ELEMENT | BRIEF DESCRIPTION | BUILDING DESIGNATION | CONDITION (INCLUDING IF DISUSED) | CONTRIBUTION TO THE CA (CAA) | OBSERVATIONS / RECOMMENDATIONS | IMAGE |
|---|--|---|--|---|--|---|
| 44A, 44B and 45 | <ul style="list-style-type: none">Semi-detached two-storey house of red brick Flemish bond and slate roof with stacks at either end.Ground floor bay windows and doors are roofed in slate to create large porches.Two arched windows each on first floor. | None | Good | 4 | <p>Remove aerials if redundant.</p> <p>Remove redundant services and tidy remainder.</p> <p>Reinstate missing boundary demarcations.</p> | |

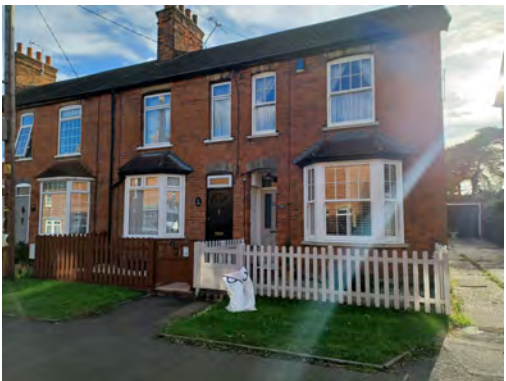
| BUILDING / STRUCTURE ELEMENT | BRIEF DESCRIPTION | BUILDING DESIGNATION | CONDITION (INCLUDING IF DISUSED) | CONTRIBUTION TO THE CA (CAA) | OBSERVATIONS / RECOMMENDATIONS | IMAGE |
|---|--|---|--|---|--|---|
| 48, 49, 50 and 51 | <ul style="list-style-type: none">Row of four terraced houses of red brick Flemish with a central stack and one at either end, roofed in concrete tiles.Each has two windows on first floor and a bay window roofed in plain red tiles on the ground floor. | None | Good | 4 | <p>Remove aerials if redundant.</p> <p>Remove redundant services and tidy remainder.</p> <p>Reinstate missing boundary demarcations.</p> | |

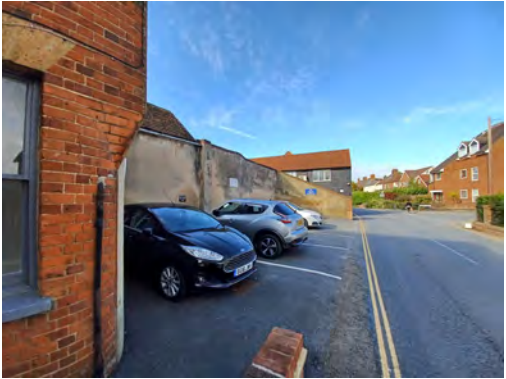
| BUILDING / STRUCTURE ELEMENT | BRIEF DESCRIPTION | BUILDING DESIGNATION | CONDITION (INCLUDING IF DISUSED) | CONTRIBUTION TO THE CA (CAA) | OBSERVATIONS / RECOMMENDATIONS | IMAGE |
|---|--|---|--|---|---|---|
| Rear of No.66 and Car Park | <ul style="list-style-type: none">Rear corner of No.66 in red brick with decorative yellow brick courses has corbelling.Extending from the rear of the property is a c.15ft high rendered brick wall which partially encloses six parking spaces perpendicular to it. | None | Fairly Poor | Not included in CAA 2 | Investigate failing render and remove and replace or repair as appropriate. Tidy loose wiring. | |
