Rowenna Wood / Edward Davis
On behalf of Purcell ®
St Mary's Hall, Rawstorn Road, Colchester, Essex CO3 3JH
rowenna.wood@purcelluk.com
www.purcelluk.com

INGATESTONE, ESSEX: HIGH STREET VISUAL AUDIT

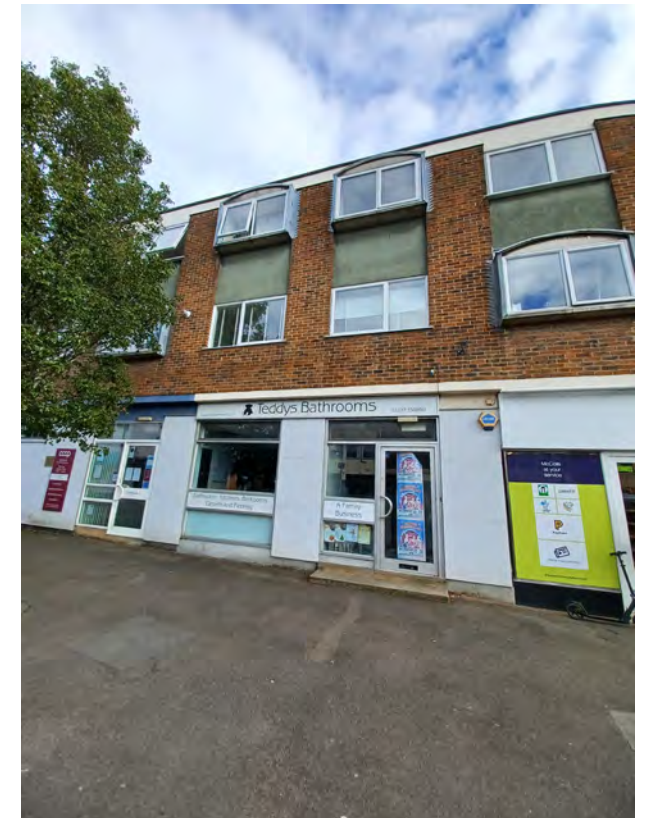
Shopfront of No.47, an empty bathroom suppliers.

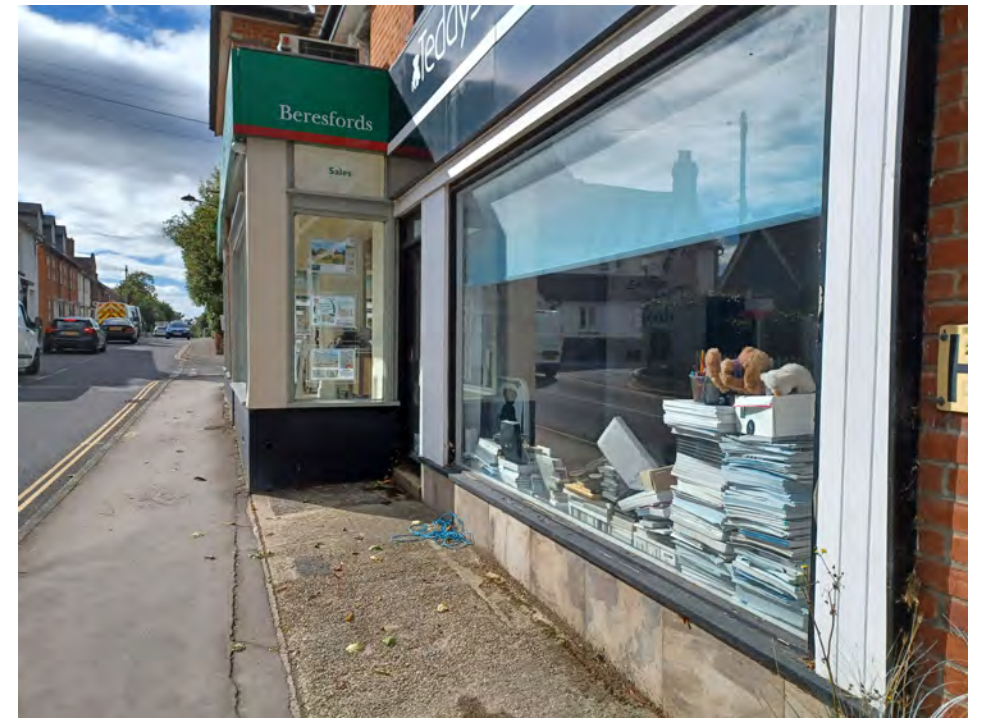
The plain shop front at 122a High Street is marred by rubbish

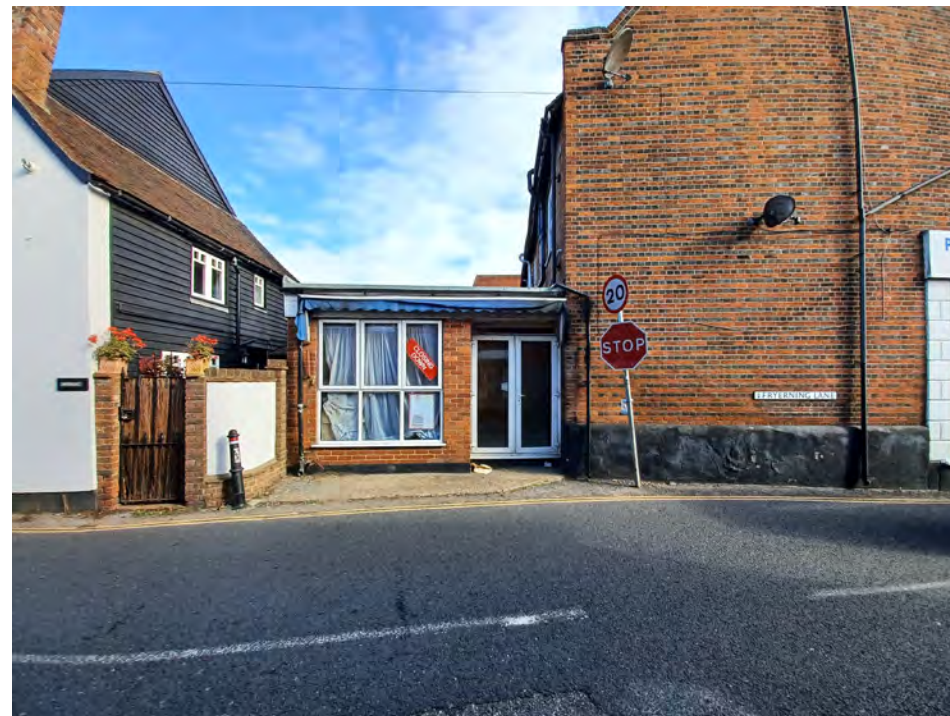
An empty shop front on Fryerning Lane, to the rear of 66 High Street.

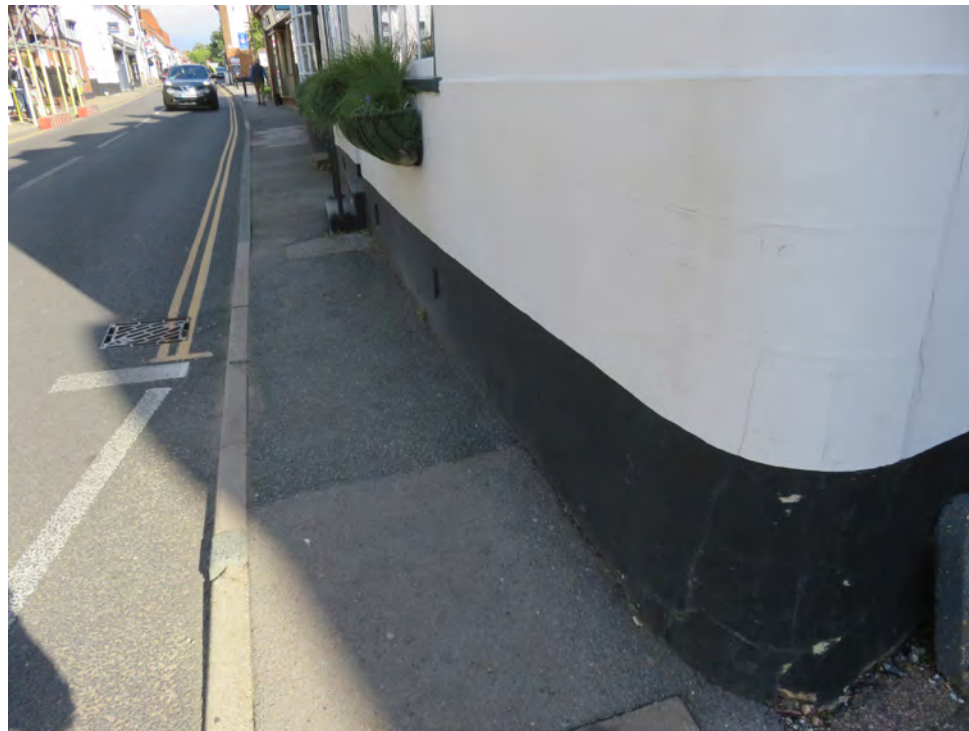
Extremely narrow pavement outside the Star PH.

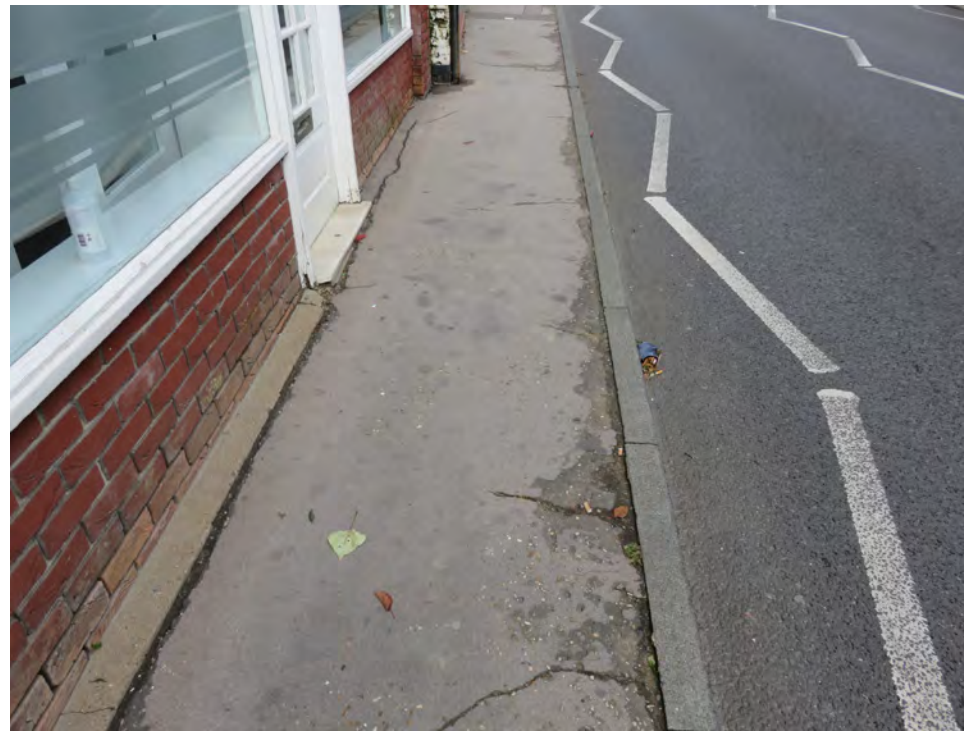
Narrow pavement outside 72-74 High Street.

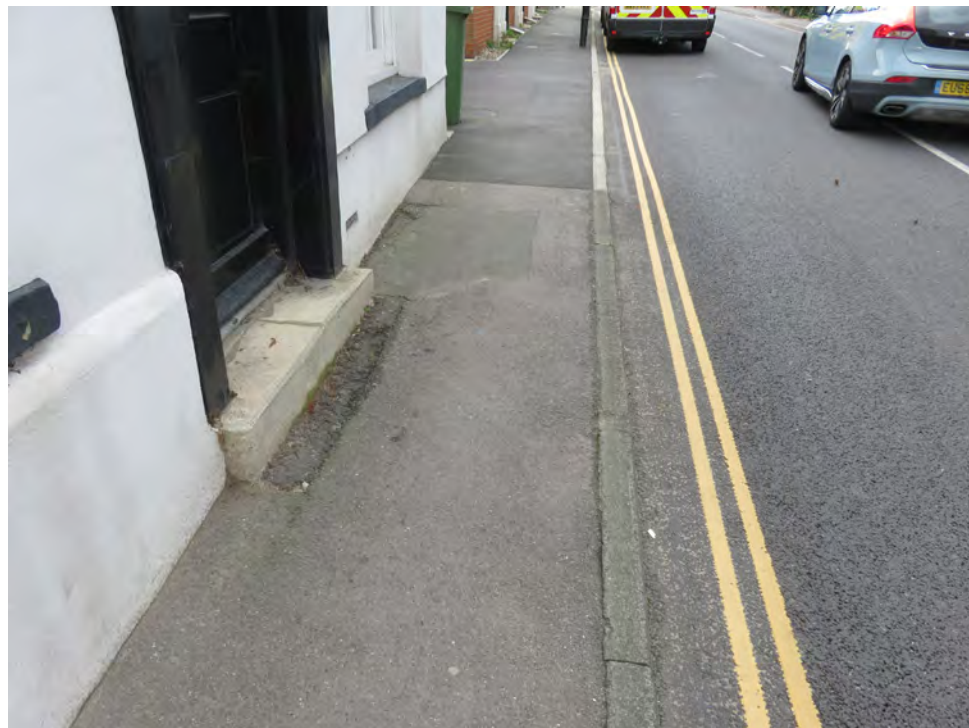
One step-up access into the former Crown PH.

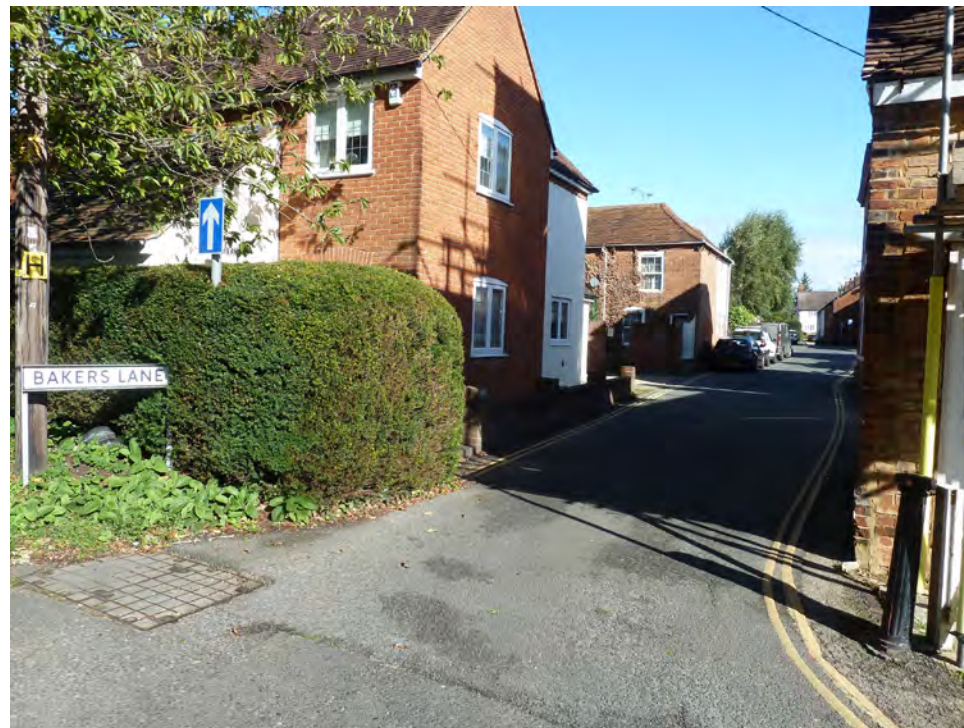
The sharp turn entrance into the narrow Bakers Lane, with no pavement.

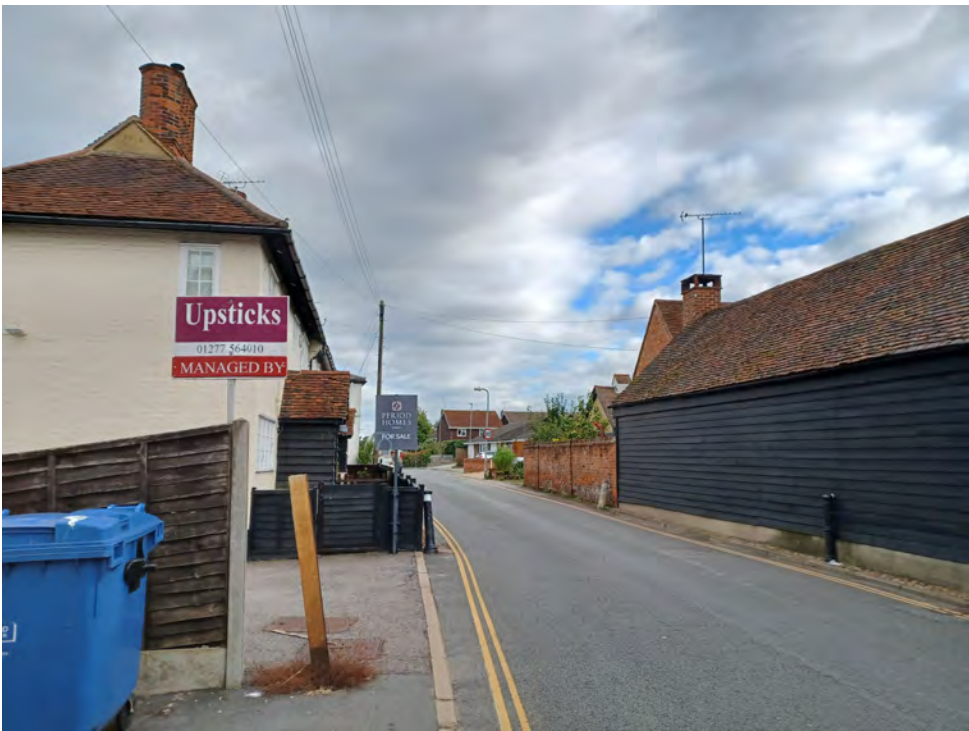
The point where the pavement disappears on Stock Lane.

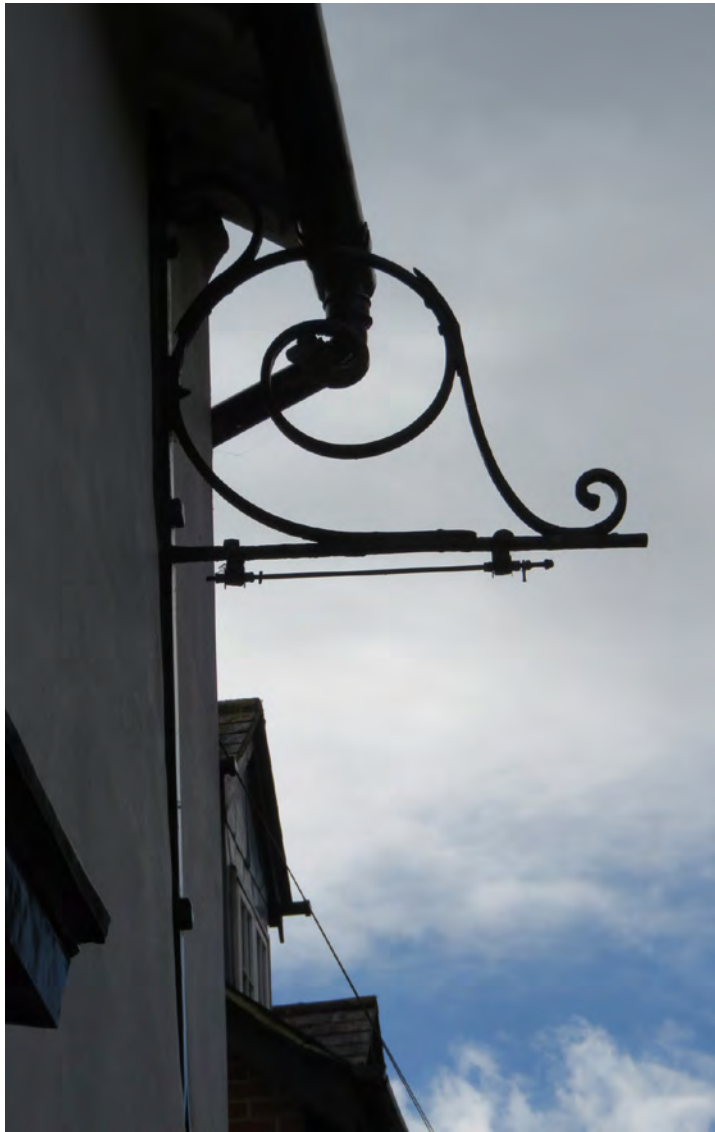
Brackets where pub signs used to hang.

Flags could be installed to mark different occasions throughout the year that could be fixed into the Christmas tree holders so that these are not empty for eleven months. The flags should not be used all the time so that the historic appearance of the street can be appreciated and so that the flags do not quickly deteriorate.

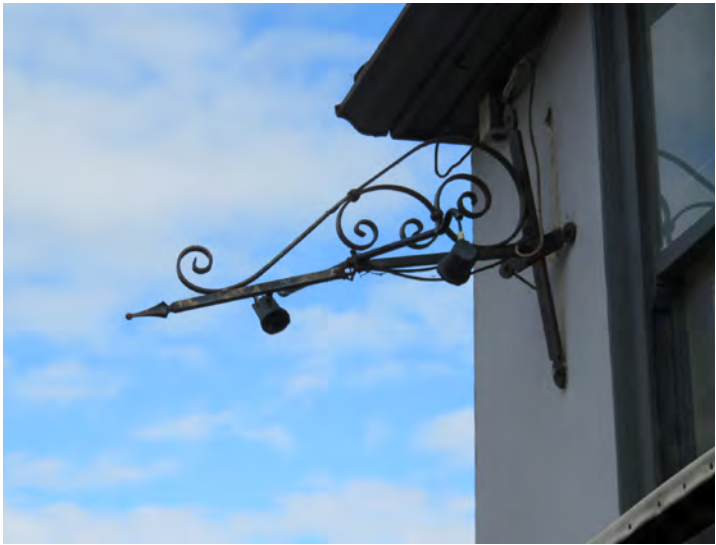
Historic bracket that has become partially detached from the wall

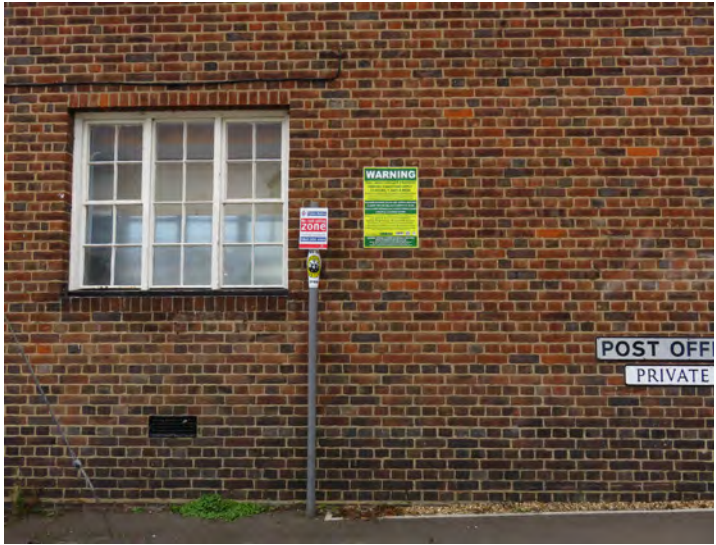
Disused signpost.

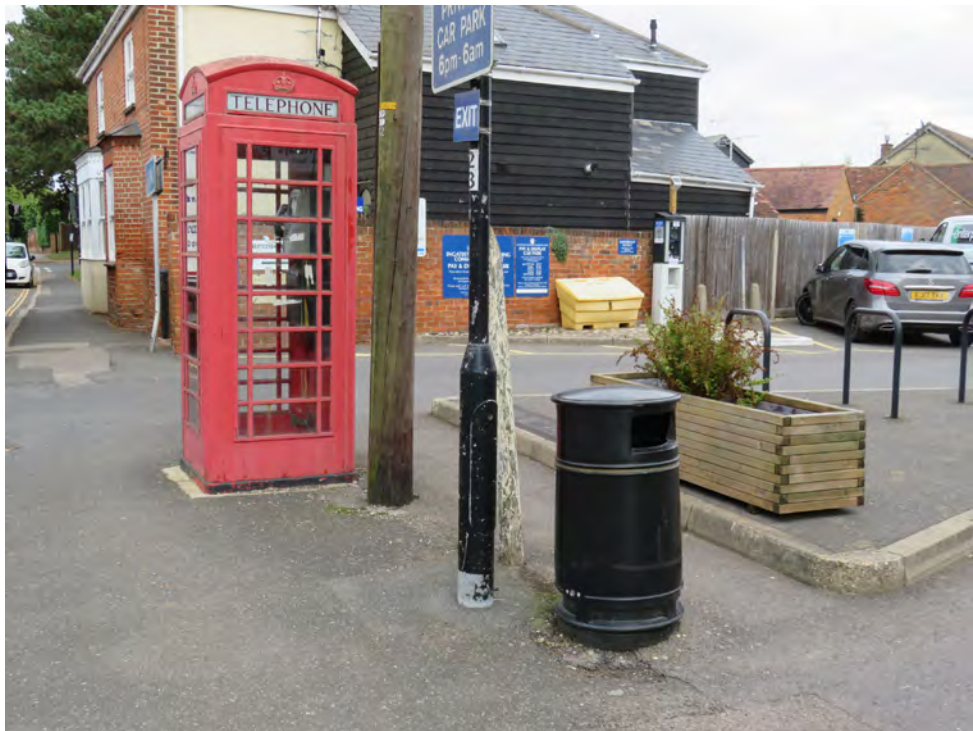
The only telephone box is by the community centre car park. It is in relatively satisfactory condition, although, as a Grade II listed feature, and now a historic piece of the community. It would benefit from repainting.

K6 Telephone Kiosk

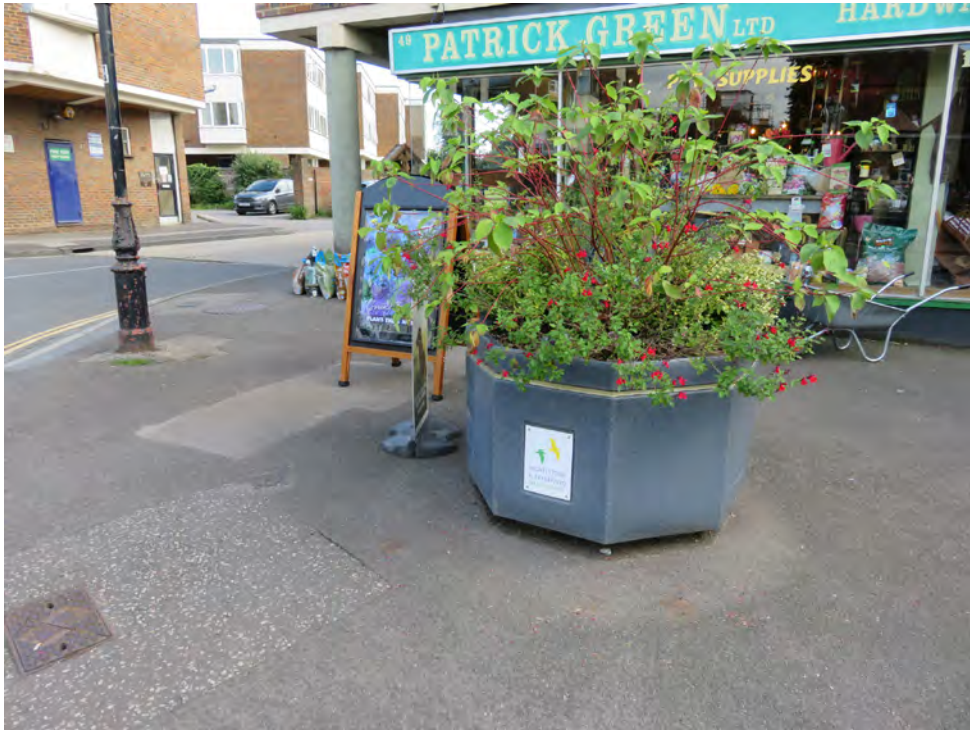
There are a variety of planters along the High Street, some of which are owned by the Council and some are owned by building owners. The large Council planters in the Square are plastic and make little aesthetic contribution whilst providing an obstruction. The planted beds in front of the church could also be improved. Planting can enhance an urban streetscape and considered planting should be encouraged but it should be co-ordinated to avoid blocking the pavements.

Large planter in Market Square, obscuring shops and obstructing pedestrians

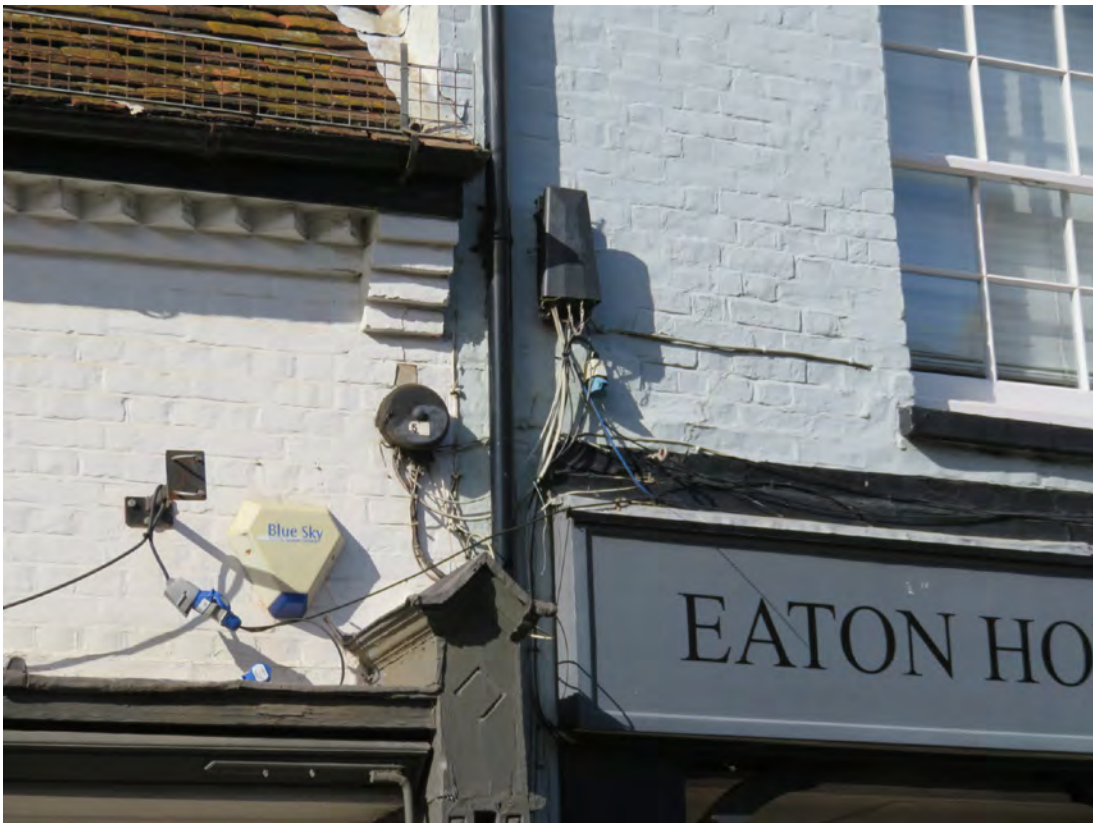
Services are essential to the functioning of buildings but they can detract from the appearance of buildings or the streetscape as a whole. There are many buildings with surface mounted wiring, security alarm boxes and other services boxes that detract from the appearance of the buildings, especially when not adequately fixed.

Untidy and potentially dangerous wiring on shop fronts.

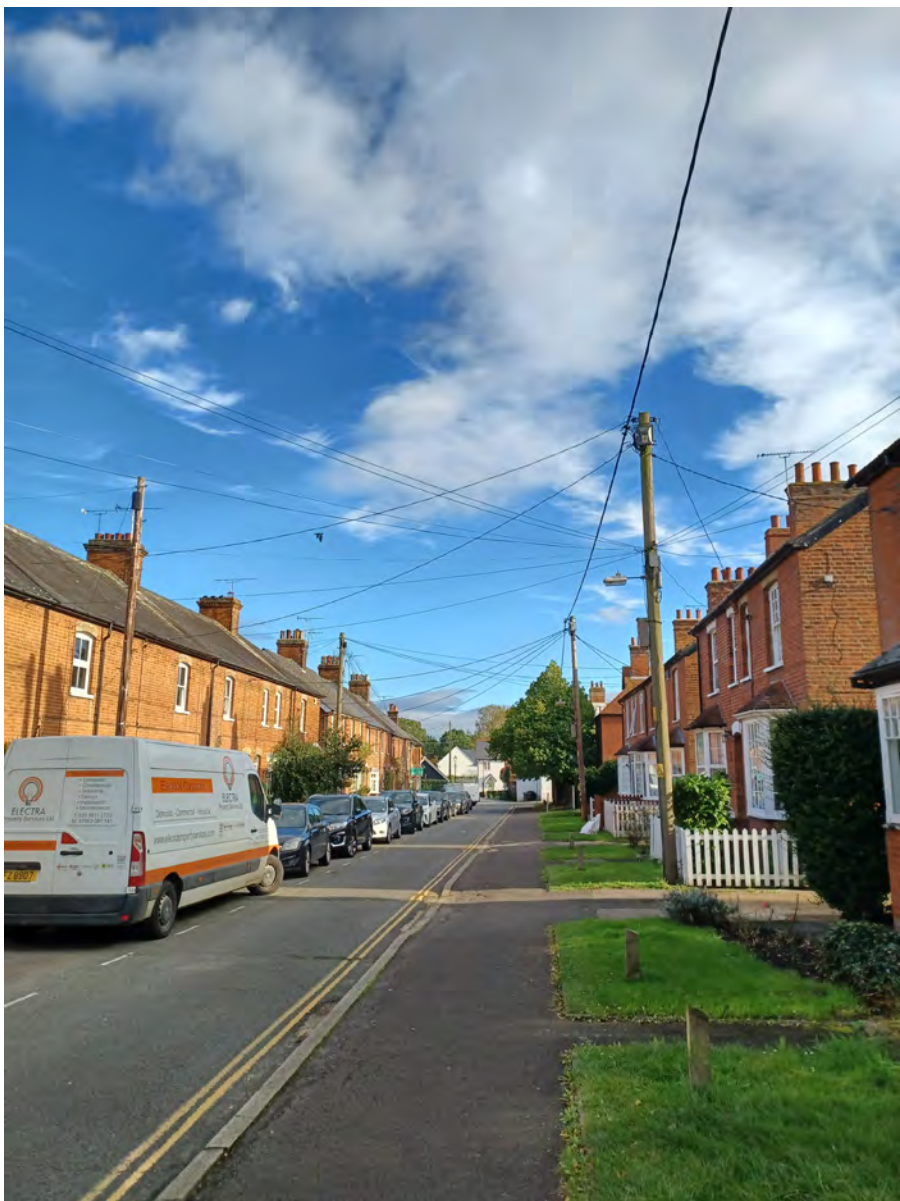
The High Street has few telegraph poles and these generally do not intrude on the streetscape. Along Norton Road, there appears to be a profusion of wires serving the many small houses.

Spider's web of telegraph poles and wiring on Norton Road

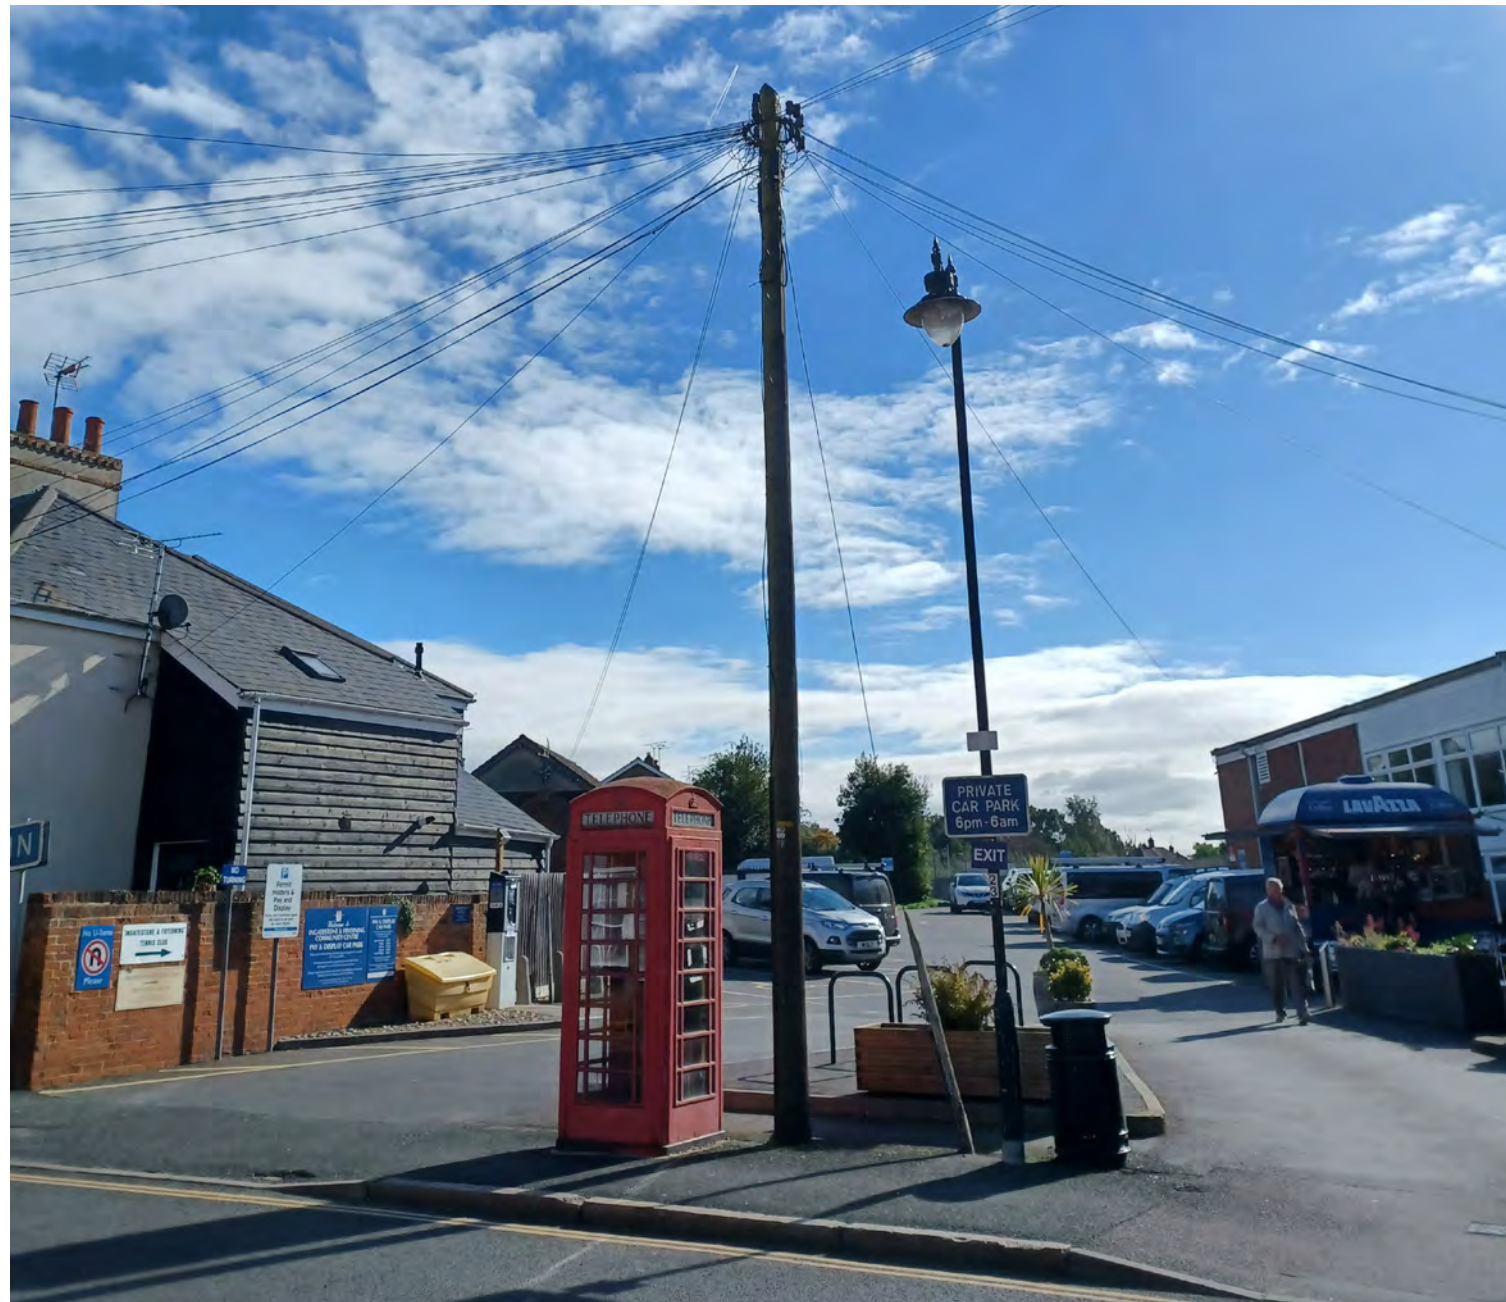
The car park at Market Place is free although has some designated corporate spaces. It is commonly used for parking while people shop, and it sometimes hosts a market. The other car park is at the Community Centre, which partially runs of the proceeds of the parking spaces in its car park. Both of these car parks are open surface car parks with poor boundary demarcations along the street.

View of the Car Park at the Community Centre

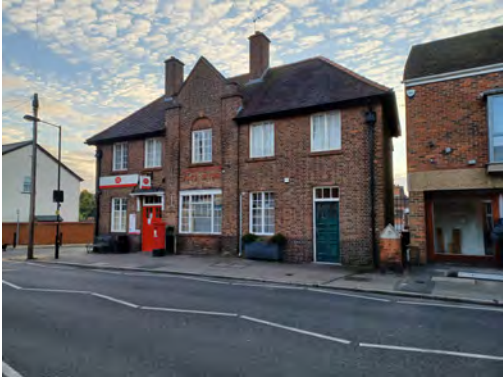
| BUILDING / STRUCTURE ELEMENT | BRIEF DESCRIPTION | BUILDING DESIGNATION | CONDITION (INCLUDING IF DISUSED) | CONTRIBUTION TO THE CA (CAA) | OBSERVATIONS / RECOMMENDATIONS | IMAGE |
|---|--|---|--|---|---|---|
| Post Office | <ul style="list-style-type: none"> Two-storeys, red brick Flemish bond and plain tiled roof. Five bays, the middle gabled with arch and relieving arch on the upper and lower windows respectively. Two timber-panelled streetside doors. South-east range, gabled end, extends at one-storey on Post Office Road to enclosed yard/car park. | None | Good | 4 | Removal of the vent in the window. Space for more benches; potentially a 2022 Jubilee bench to complement the existing 1977 bench. | |

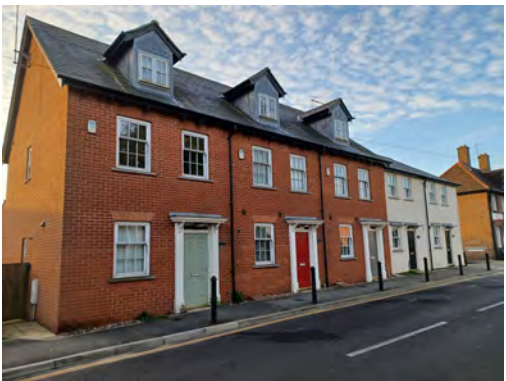
| BUILDING / STRUCTURE ELEMENT | BRIEF DESCRIPTION | BUILDING DESIGNATION | CONDITION (INCLUDING IF DISUSED) | CONTRIBUTION TO THE CA (CAA) | OBSERVATIONS / RECOMMENDATIONS | IMAGE |
|---|---|---|--|---|--|---|
| 1-5 Meadows Cottages | <ul style="list-style-type: none">• Five recently built compact houses.• Window and front door on ground floor; two windows on first floor roofed in slate.• Nos.1-3 brick stretcher bond with gabled dormers.• Nos.4-5 rendered/plastered with brick garden wall stretching from end of No.5 down Post Office Road.• On site of former garage. | None | Good | 3 | Opportunity to have more decorative, greener fronts. | |

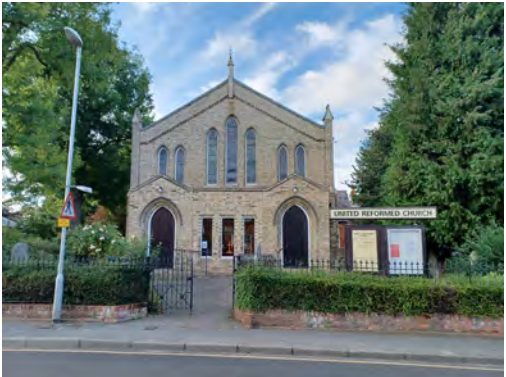
| BUILDING / STRUCTURE ELEMENT | BRIEF DESCRIPTION | BUILDING DESIGNATION | CONDITION (INCLUDING IF DISUSED) | CONTRIBUTION TO THE CA (CAA) | OBSERVATIONS / RECOMMENDATIONS | IMAGE |
|---|--|---|--|---|---|---|
| United Reformed Church | <ul style="list-style-type: none">Set back in church yard with black iron railings.Gothic revival, white brick Flemish bond.Gable ended pinnacles, corniced string course and seven gothic lights.Twin porches with timber pointed arch doors and brick mouldings. | None | Good | 5 | Bricks of boundary wall and piers delaminated and corroding. Wall should be monitored and the missing or badly damaged bricks replaced. | |

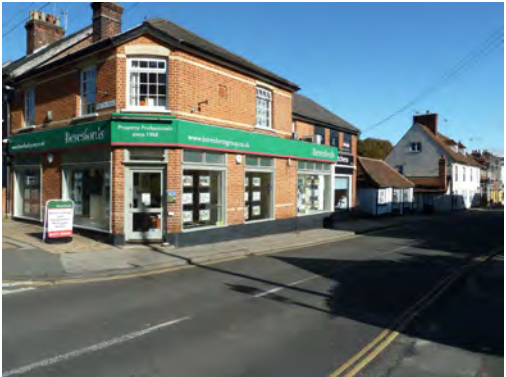
| BUILDING / STRUCTURE ELEMENT | BRIEF DESCRIPTION | BUILDING DESIGNATION | CONDITION (INCLUDING IF DISUSED) | CONTRIBUTION TO THE CA (CAA) | OBSERVATIONS / RECOMMENDATIONS | IMAGE |
|---|---|---|--|--|--|---|
| 122, Beresfords Estate Agents | <ul style="list-style-type: none">• Brick Flemish bond corner building.• Two-storeys with small single-storey extension to the north-east.• Six large shop windows with moulded timbers.• Large metallic/plastic signage.• Slate roof.• Decorative terracotta flower on High Street elevation. | None | Good | 4 | Air conditioning units and wires clearly visible on roof of extension from the street. | |

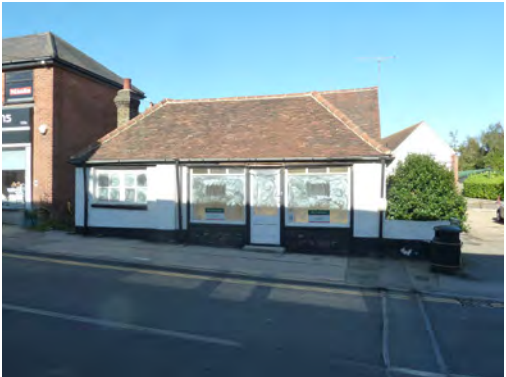
| BUILDING / STRUCTURE ELEMENT | BRIEF DESCRIPTION | BUILDING DESIGNATION | CONDITION (INCLUDING IF DISUSED) | CONTRIBUTION TO THE CA (CAA) | OBSERVATIONS / RECOMMENDATIONS | IMAGE |
|---|--|---|--|---|--|---|
| 120 | <ul style="list-style-type: none">Single-storey shop, possibly timber framed and plastered.Larger range at the rear with first floor attic and visible bullseye widow.Roofed in plain tiles.Large double shop windows with door between. | None | Disused | 4 | <p>Repairs needed to windows, sills and timber casements of shop window.</p> <p>Driveway wall partially collapsing and bricks missing.</p> | |

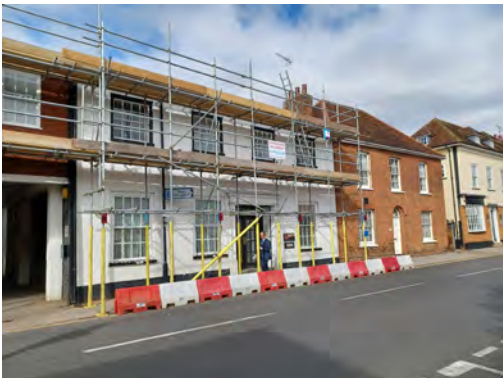
| BUILDING / STRUCTURE ELEMENT | BRIEF DESCRIPTION | BUILDING DESIGNATION | CONDITION (INCLUDING IF DISUSED) | CONTRIBUTION TO THE CA (CAA) | OBSERVATIONS / RECOMMENDATIONS | IMAGE |
|---|--|---|--|---|--|---|
| 106-108 | <ul style="list-style-type: none">Early nineteenth century altered and extended in the twentieth.Two-storey timber framed, plastered and roofed in slate.Recessed porch/lobby with double doors and classical timber casement – currently obscured by scaffolding. | Grade II | Good | 5 | Evidence of damp at ground floor level. This should be investigated. It may be that the render or the paint is not breathable and needs replacing. | |

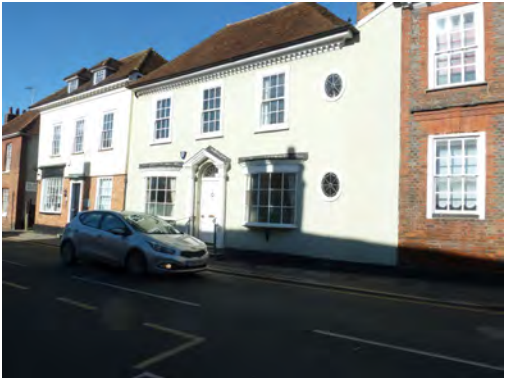
| BUILDING / STRUCTURE ELEMENT | BRIEF DESCRIPTION | BUILDING DESIGNATION | CONDITION (INCLUDING IF DISUSED) | CONTRIBUTION TO THE CA (CAA) | OBSERVATIONS / RECOMMENDATIONS | IMAGE |
|---|--|---|--|---|---|---|
| 100 | <ul style="list-style-type: none">• Late eighteenth century two-storey house.• Restored in twentieth century.• Timber framed, plastered and weatherboarded, roofed in red clay tiles.• Two steps up to floor between a pair of iron rails.• Ionic pilasters on door casement.• Fan light above door.• Partial course of dentiled cornice.• Two bow windows of 15 lights.• Stretches to the right to connect with No.98.• Two oval windows | Steps and handrails are Grade II | Fairly Good | 5 | Repaint joinery, base and leadwork. | |

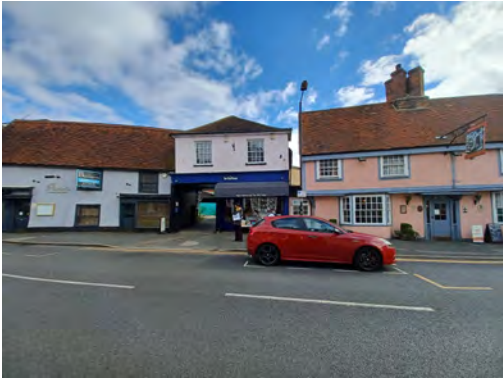
| BUILDING / STRUCTURE ELEMENT | BRIEF DESCRIPTION | BUILDING DESIGNATION | CONDITION (INCLUDING IF DISUSED) | CONTRIBUTION TO THE CA (CAA) | OBSERVATIONS / RECOMMENDATIONS | IMAGE |
|---|---|---|--|---|---|---|
| 53, The Old Forge | <ul style="list-style-type: none">Two-storey brick building with ground floor shop front with awning on the right and black timber weatherboarded vehicle passageway through to the rear on the left. | Grade II | | 5 | <p>Remove redundant alarm box.</p> <p>Repaint upper storey.</p> | |

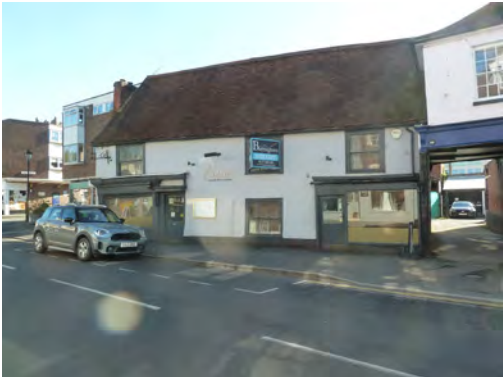
| BUILDING / STRUCTURE ELEMENT | BRIEF DESCRIPTION | BUILDING DESIGNATION | CONDITION (INCLUDING IF DISUSED) | CONTRIBUTION TO THE CA (CAA) | OBSERVATIONS / RECOMMENDATIONS | IMAGE |
|---|---|---|--|---|---|---|
| 51, Piero's | <ul style="list-style-type: none">Former house now empty restaurant.Early sixteenth century extended early seventeenth and nineteenth centuries.Two-storeys, timber framed, plastered and weatherboarded, roofed with red clay tiles.Long range of four bays.Two timber cased shopfront windows and doors.North-east gable end exposed to the marketplace with two red brick external chimneys and a single-storey rear range. | Grade II | Disused | 5 | <p>Loose electrical wires and loose roof tiles. North-east chimneys may need bracing or realignment.</p> <p>Refix loose (and potentially dangerous) sign bracket.</p> | |

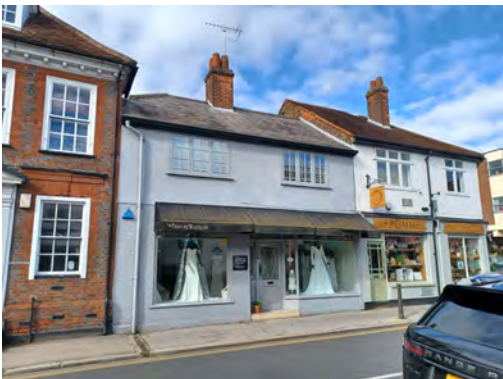
| BUILDING / STRUCTURE ELEMENT | BRIEF DESCRIPTION | BUILDING DESIGNATION | CONDITION (INCLUDING IF DISUSED) | CONTRIBUTION TO THE CA (CAA) | OBSERVATIONS / RECOMMENDATIONS | IMAGE |
|---|---|---|--|---|---|---|
| 96, The Bespoke Wardrobe | <ul style="list-style-type: none">Two-storey shop, brick with plastered upper floor.Two ground floor shop windows and two upper windows of 18 lights.Slate roof and one central brick chimney.Large triple awning. | None | | 4 | <p>Clean awning.</p> <p>Remove aerial if redundant.</p> | |

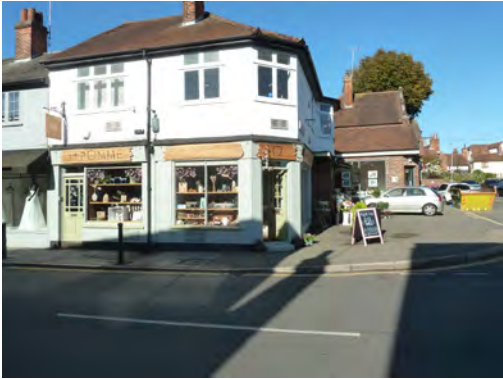
| BUILDING / STRUCTURE ELEMENT | BRIEF DESCRIPTION | BUILDING DESIGNATION | CONDITION (INCLUDING IF DISUSED) | CONTRIBUTION TO THE CA (CAA) | OBSERVATIONS / RECOMMENDATIONS | IMAGE |
|---|---|---|--|---|---|---|
| 94 / I Market Place, La Pomme | <ul style="list-style-type: none">Two-storey shop, possibly two units, positioned on the corner of the High Street and the market place with a door at the corner axis, and a semi-circular step.Three large ground floor shop windows. | None | | 4 | <p>Remove redundant wiring and fix the remainder tidily.</p> <p>Redecorate upper level joinery.</p> <p>Remove vents if possible.</p> | |

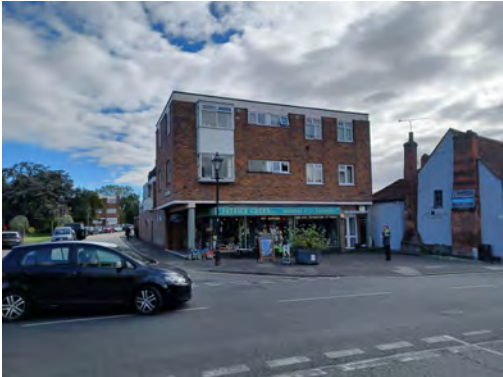
| BUILDING / STRUCTURE ELEMENT | BRIEF DESCRIPTION | BUILDING DESIGNATION | CONDITION (INCLUDING IF DISUSED) | CONTRIBUTION TO THE CA (CAA) | OBSERVATIONS / RECOMMENDATIONS | IMAGE |
|---|---|---|--|---|---|---|
| 49, Patrick Green | <ul style="list-style-type: none">Twentieth century three-storey apartment building.Brick stretcher bond, with plaster parapet.Jettied over a glass fronted shop.First and second floor window box. | None | | 2 | <p>This is a more considered piece of design than No.47 and has a good example of a Modern shopfront.</p> <p>The uPVC windows and side door detract from the building's appearance.</p> | |

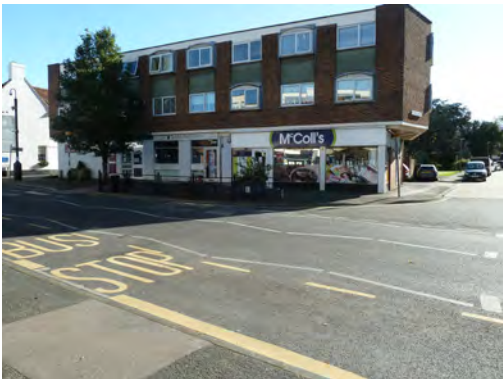
| BUILDING / STRUCTURE ELEMENT | BRIEF DESCRIPTION | BUILDING DESIGNATION | CONDITION (INCLUDING IF DISUSED) | CONTRIBUTION TO THE CA (CAA) | OBSERVATIONS / RECOMMENDATIONS | IMAGE |
|---|---|---|--|---|---|---|
| 47, McColl's, Teddy's Bathrooms, Co Op Ingatestone Funeral Directors | <ul style="list-style-type: none">Long twentieth century range three-storeys of eight first and second floor windows with alternating recessed fenestration and green asphalt between the levels.Slightly jettied over ground floor of three varied shop fronts. | None | Teddy's is disused. | 2 | <p>Removing the film from the shop windows of McColl's would improve the appearance.</p> | |

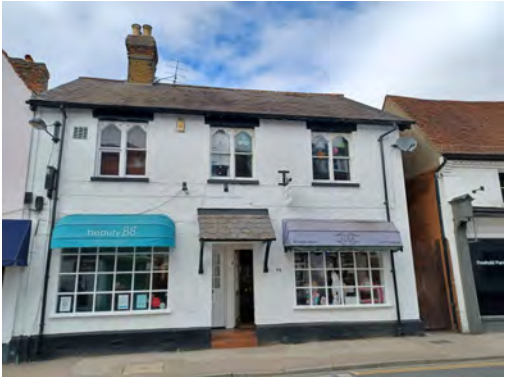
| BUILDING / STRUCTURE ELEMENT | BRIEF DESCRIPTION | BUILDING DESIGNATION | CONDITION (INCLUDING IF DISUSED) | CONTRIBUTION TO THE CA (CAA) | OBSERVATIONS / RECOMMENDATIONS | IMAGE |
|---|--|---|--|---|--|---|
| 88 and 86, Beauty and Aura | <ul style="list-style-type: none">Probably originally one house.Two-storey brick Flemish bond with slate roof.Internal porchway with two separate front doors.Timber bracketed porch roof with hexagonal slate tiles.Two large shop front windows of 24 lights and awnings.The right window is slightly bowed.The three first floor windows of two lights, decorative timber casements with trefoils in the spandrels. | None | | 4 | <p>Remove any redundant cables and securely fix and paint the remainder.</p> <p>Replace or redecorate the wall mounted street lamp and remove/relocate the junction box to a less obtrusive location.</p> <p>Remove aerial if redundant.</p> | |

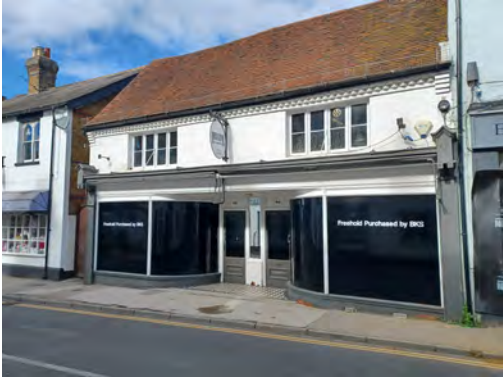
| BUILDING / STRUCTURE ELEMENT | BRIEF DESCRIPTION | BUILDING DESIGNATION | CONDITION (INCLUDING IF DISUSED) | CONTRIBUTION TO THE CA (CAA) | OBSERVATIONS / RECOMMENDATIONS | IMAGE |
|---|--|---|--|---|--|---|
| 82 and 84 | <ul style="list-style-type: none">Two-storey seventeenth century, altered late nineteenth century, shop.Timber-framed with façade of painted brick in English bond and rendered at the side.Roofed in red clay tiles.Ground floor has large, curved floor to ceiling glazing (like Nos.39 and 39A) leading to two recessed doors.On first floor, two timber casement windows of eight lights in brick façade with a dogtooth course below the eaves. | Grade II | Empty? | 5 | Remove any redundant cables and securely fix and paint the remainder. | |

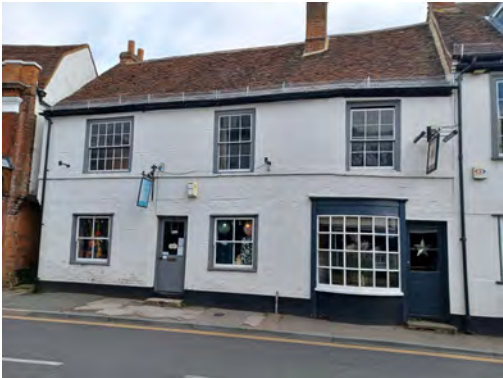
| BUILDING / STRUCTURE ELEMENT | BRIEF DESCRIPTION | BUILDING DESIGNATION | CONDITION (INCLUDING IF DISUSED) | CONTRIBUTION TO THE CA (CAA) | OBSERVATIONS / RECOMMENDATIONS | IMAGE |
|---|--|---|--|---|--|---|
| 41 and 43 | <ul style="list-style-type: none">Two shops, formerly one house.Early sixteenth century altered eighteenth and nineteenth centuries.Timber framed with façade of painted red brick Flemish bond.Roofed in red clay tiles.Ground: No.41 has two sashes of four lights and above a stone step a half-glazed door.On the first floor a sash of 10+10 lights and one of 6+6.Signs of disturbed brickwork above.Roofline of No.43 higher than No.41.No.43 has at ground a bow shop window of 24 lights. | Grade II | | 5 | Remove (or fix tidily and paint) the blue cable. | |

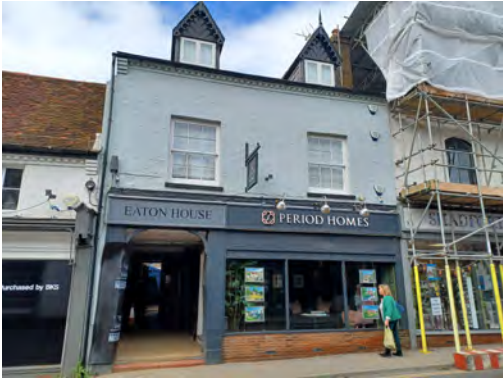
| BUILDING / STRUCTURE ELEMENT | BRIEF DESCRIPTION | BUILDING DESIGNATION | CONDITION (INCLUDING IF DISUSED) | CONTRIBUTION TO THE CA (CAA) | OBSERVATIONS / RECOMMENDATIONS | IMAGE |
|---|--|---|--|---|--|---|
| 80A, Eaton House, Period Homes | <ul style="list-style-type: none">Painted red brick Flemish bond.Two-storeys with possible carriage or walkway through to the rear framed with timber pilasters and brackets on the left.Roofed in slate.Brick dogtooth eaves cornice.Two gabled attic dormers.Two first floor sash windows of 6+6 lights.On ground a large triple shop window. | | | 4 | Remove any redundant cables and securely fix and paint the remainder. Remove the aerial if redundant. | |

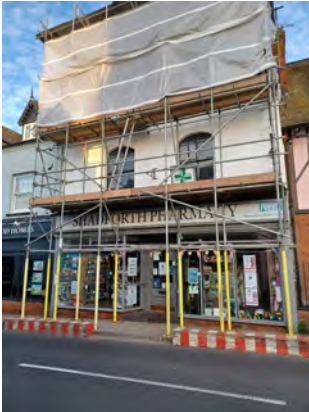
| BUILDING / STRUCTURE ELEMENT | BRIEF DESCRIPTION | BUILDING DESIGNATION | CONDITION (INCLUDING IF DISUSED) | CONTRIBUTION TO THE CA (CAA) | OBSERVATIONS / RECOMMENDATIONS | IMAGE |
|---|--|---|--|---|---|--|
| 80, Shadforth Pharmacy | <ul style="list-style-type: none">Two-storeys.Painted brick Flemish and English Bond.Ground floor has floor to ceiling shop windows with mostly glazed door in between with wooden rails.Two arched sash windows at first floor with 2+2 lights and key stones.Decorative stepped brick eaves cornice and remnants of lost plaster pilasters at either end. | None | | 4 | Repaint the upper storey. | |

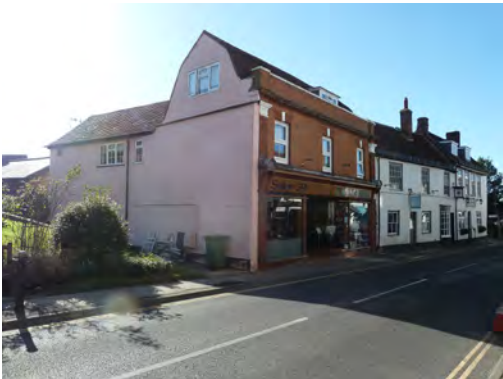
| BUILDING / STRUCTURE ELEMENT | BRIEF DESCRIPTION | BUILDING DESIGNATION | CONDITION (INCLUDING IF DISUSED) | CONTRIBUTION TO THE CA (CAA) | OBSERVATIONS / RECOMMENDATIONS | IMAGE |
|---|--|---|--|---|---|--|
| 39 and 39A | <ul style="list-style-type: none">Late eighteenth/early nineteenth century, altered in twentieth century.Two-storeys with attic and dormer.Timber framed, plastered with High Street elevation fitted with façade and parapet of red brick Flemish bond.Roofed in red clay tiles.Main range rectangular with gambrel gable.Front elevation: First floor of three, late nineteenth century sashes of four lights. Two pilasters of brick at either end with ovolo stone capitals. Modillioned and moulded cornice. Brick corbel at the western corner.Ground floor: Large, curved floor-to-ceiling glazing (very similar to Nos.82 and 84).Churchyard elevation: Two first floor windows and one attic window visible. Timber and decorative plasterwork visible on main and rear extended ranges. | Grade II | | 5 | <p>Windows have very recently been replaced with uPVC windows, which harm the appearance of the building.</p> <p>Relocate security alarm from the shop front bracket.</p> | |

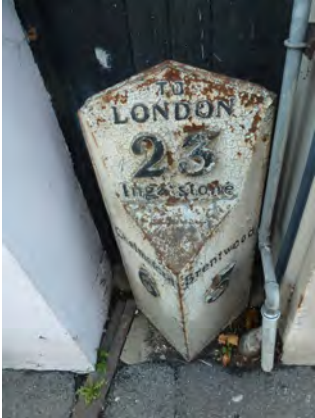
| BUILDING / STRUCTURE ELEMENT | BRIEF DESCRIPTION | BUILDING DESIGNATION | CONDITION (INCLUDING IF DISUSED) | CONTRIBUTION TO THE CA (CAA) | OBSERVATIONS / RECOMMENDATIONS | IMAGE |
|---|--|---|--|---|---|--|
| Milepost between numbers 74 and 76 | <ul style="list-style-type: none">Triangular plan.Embossed: 'Chelmsford 6', 'Brentwood 5' and 'London 23, Ingatestone'. Cary: 1790-:48. | Grade II | | 4 | Conserve. | |

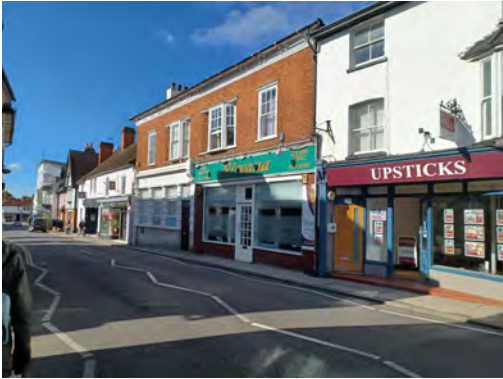
| BUILDING / STRUCTURE ELEMENT | BRIEF DESCRIPTION | BUILDING DESIGNATION | CONDITION (INCLUDING IF DISUSED) | CONTRIBUTION TO THE CA (CAA) | OBSERVATIONS / RECOMMENDATIONS | IMAGE |
|---|---|---|--|---|---|---|
| 72 and 74 | <ul style="list-style-type: none">Former house, now shops.Early nineteenth century altered nineteenth and twentieth centuries.Timber framed with brick façade of red brick Flemish bond.Hipped roof of slate.Ground floor of No.72 has twentieth century shop frontage of brick stretcher and large windows.Ground floor of No.74 has an earlier form with three windows and rusticated, plastered pilasters and consoles.First floor: a pair of splayed bays set back within recessed straight heads and splayed brick jambs, between two further plainer sash windows.Moulded, modillioned wooden eaves cornice. | Grade II | Part empty? | 4 | <p>Remove redundant alarm from former bank.</p> <p>Remove redundant wiring and refix any remiaing wiring neatly ont he side of the former bank.</p> | |

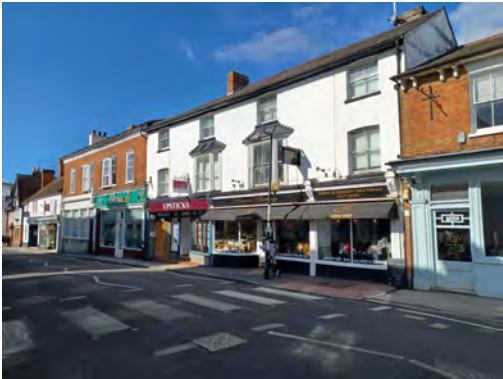
| BUILDING / STRUCTURE ELEMENT | BRIEF DESCRIPTION | BUILDING DESIGNATION | CONDITION (INCLUDING IF DISUSED) | CONTRIBUTION TO THE CA (CAA) | OBSERVATIONS / RECOMMENDATIONS | IMAGE |
|---|---|---|--|---|---|---|
| 70A, 70 and 68 Upsticks and Ravens Bakery | <ul style="list-style-type: none">Three-storey row of two shops and residential flats, painted brick Flemish bond.Upper floors have six sash windows of 4+4 lights and two central lead roofed oriel windows on the first floor.Ground floor: left shop bay slightly recessed with two doors and shop window.Right shop: of six large shopwindows and slightly recessed glazed door with awnings overall. | None | | 4 | <p>Remove aerial if redundant.</p> | |

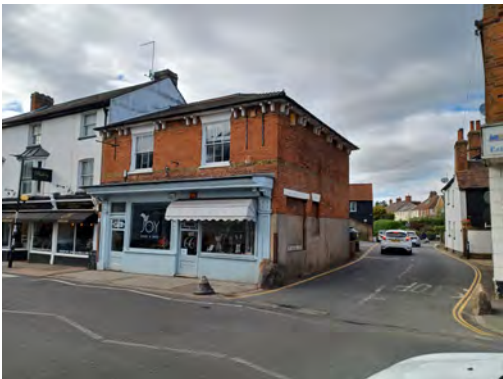
| BUILDING / STRUCTURE ELEMENT | BRIEF DESCRIPTION | BUILDING DESIGNATION | CONDITION (INCLUDING IF DISUSED) | CONTRIBUTION TO THE CA (CAA) | OBSERVATIONS / RECOMMENDATIONS | IMAGE |
|---|---|---|--|---|---|---|
| 66, Joy: Shoes and Bags | <ul style="list-style-type: none">End of row shop.Two-storey, red brick Flemish bond with some yellow brick string courses, roofed with slate.Large timber shop window casement of two doors with fan lights and two windows, an awning over the right.Two sash windows of 1+1 lights and decorative timber brackets in the eaves. | None | | 4 | <p>Remove redundant alarm boxes.</p> <p>Remove or tidy and paint blue cable.</p> <p>Repair threshold.</p> | |

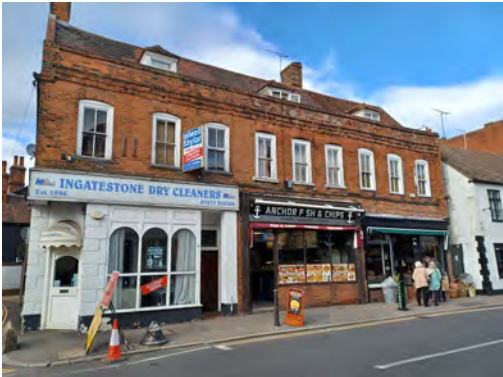
| BUILDING / STRUCTURE ELEMENT | BRIEF DESCRIPTION | BUILDING DESIGNATION | CONDITION (INCLUDING IF DISUSED) | CONTRIBUTION TO THE CA (CAA) | OBSERVATIONS / RECOMMENDATIONS | IMAGE |
|--|--|---|--|---|---|---|
| 60,62 and 64 | <ul style="list-style-type: none">Terrace of three houses now shops and accommodation over.Early eighteenth century extended and altered nineteenth and twentieth centuries.Red and blue brick Flemish bond, roofed in red clay tiles.Side elevation of English bond.First floor has a row of nine sash windows of 2+2 lights with slightly curved arches.Under a brick string course and parapet. | Grade II | | 5 | <p>Brickwork repairs needed to parapet and elsewhere on front elevation. Cementitious mortar repairs should be removed.</p> <p>Remove redundant wires and refix and paint those that are needed.</p> <p>Remove timber signboard supports.</p> <p>Redecorate upper floor joinery.</p> <p>Remove aerials if redundant.</p> <p>Replace shop signs with better quality signas (eg painted timber)</p> | |
