Rowenna Wood / Edward Davis
On behalf of Purcell ®
St Mary's Hall, Rawstorn Road, Colchester, Essex CO3 3JH
rowenna.wood@purcelluk.com
www.purcelluk.com

INGATESTONE, ESSEX: HIGH STREET VISUAL AUDIT

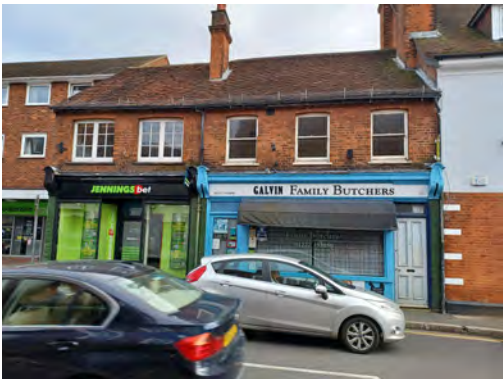
| BUILDING / STRUCTURE ELEMENT | BRIEF DESCRIPTION | BUILDING DESIGNATION | CONDITION (INCLUDING IF DISUSED) | CONTRIBUTION TO THE CA (CAA) | OBSERVATIONS / RECOMMENDATIONS | IMAGE |
|--|--|---|--|---|---|---|
| 21 and 19, Galvin Family Butchers and Jennings Bet | <ul style="list-style-type: none">Range of three shops in red brick Flemish bond, red clay tile roof and central stack – two-storeys.No.21 has three first floor 1+1 sash windows, No.19 has two windows.No.21 has a large shop window and awning with two doors either side, the left being of four panels.No.19 has four shop floor to ceiling shop windows and a partially glazed door. | None | Range of two shops | 5 | <p>Remove redundant wires and refix and paint those that are needed.</p> | |

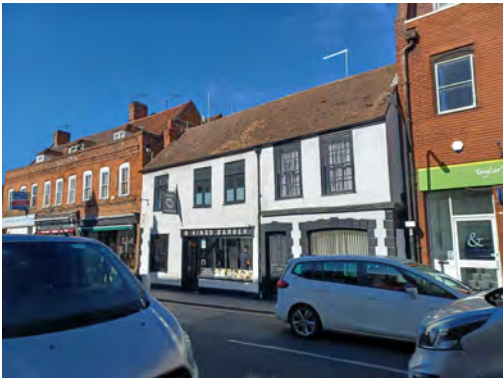
| BUILDING / STRUCTURE ELEMENT | BRIEF DESCRIPTION | BUILDING DESIGNATION | CONDITION (INCLUDING IF DISUSED) | CONTRIBUTION TO THE CA (CAA) | OBSERVATIONS / RECOMMENDATIONS | IMAGE |
|--|--|---|--|---|---|---|
| Old Bank House, 56 and 58 | <ul style="list-style-type: none">Seventeenth and eighteenth century, altered in nineteenth century.Two-storeys, timber-framed, plastered and roughcast.Roofed in red tiles.At 1st floor level No.56 has two horned sash windows of 6+6 lights above a plaster moulded stringcourse.At ground floor a four panelled floor and large rectangular window with a wide sash of two lights.The jambs and arches of the door and window are rusticated in plaster.There are plaster rusticated coinings at either end of the building – two coinings are missing from the south-west end.No.58 consists of three upper floor twentieth century mullion and transomed windows and at ground, a further sash of four lights and a shop window with glazed door. | Grade II | | 5 | <p>Remove aerials if redundant.</p> | |

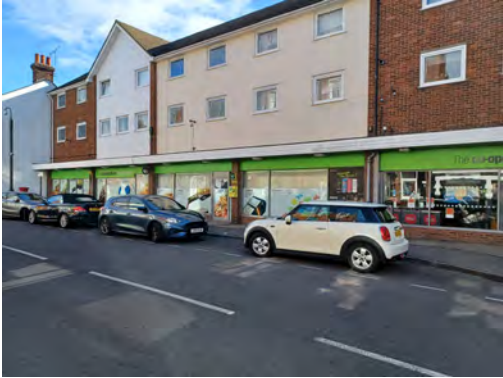
| BUILDING / STRUCTURE ELEMENT | BRIEF DESCRIPTION | BUILDING DESIGNATION | CONDITION (INCLUDING IF DISUSED) | CONTRIBUTION TO THE CA (CAA) | OBSERVATIONS / RECOMMENDATIONS | IMAGE |
|---|--|---|--|---|--|---|
| Co-Op, 1-5 | <ul style="list-style-type: none">Long three-storey range of four unequal bays with supermarket taking entire glazed ground floor.First bay of red brick stretcher bond and four windows.Second bay gabled and of white plastic weatherboarding and five windows.Third bay plastered two rows of four windows.Fourth bay of red brick stretcher bond | | | 2 | <p>Remove film from windows and create more active frontage.</p> <p>Repair cracked render.</p> | |

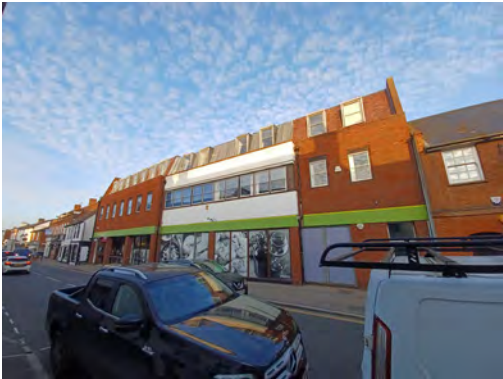
| BUILDING / STRUCTURE ELEMENT | BRIEF DESCRIPTION | BUILDING DESIGNATION | CONDITION (INCLUDING IF DISUSED) | CONTRIBUTION TO THE CA (CAA) | OBSERVATIONS / RECOMMENDATIONS | IMAGE |
|---|--|---|--|---|--|---|
| Budgens, 46-54 | <ul style="list-style-type: none">Brick stretcher bond of two-storeys with 13 attic dormers.Supermarket with offices about in three sections.The first of seven windows sets, the second of four and the third of two. | None | | 2 | <p>Remove film from windows and create more active frontage.</p> | |

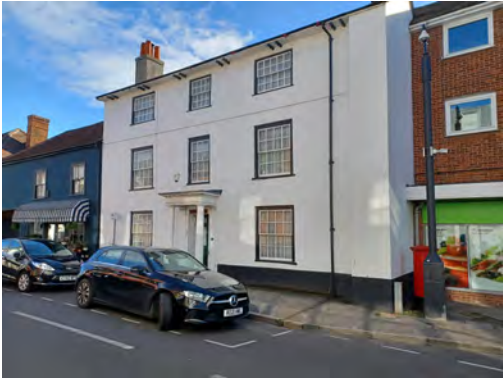
| BUILDING / STRUCTURE ELEMENT | BRIEF DESCRIPTION | BUILDING DESIGNATION | CONDITION (INCLUDING IF DISUSED) | CONTRIBUTION TO THE CA (CAA) | OBSERVATIONS / RECOMMENDATIONS | IMAGE |
|---|--|---|--|---|--|---|
| Berkley House, 13A | <ul style="list-style-type: none">Early nineteenth century and extended later that century.Three-storeys timber framed, stucco and roofed with slate.Near symmetrical high street elevation in three bays and a central Tuscan portico/porch with Doric columns around a six panelled door four of which are glazed.Ground floor: Two original sashes of 8+8 lights.First floor: Two similar sashes, and a similar central sash of 6+6 lights.Second floor: Two original sashes of 10+10 lights and a similar central sash of 8+8 lights.A plaster stringcourse runs between the first and second floors.Plastered pier protruding into the street at the south-west end. | Grade II | | 5 | <p>Remove aerial if redundant.</p> | |

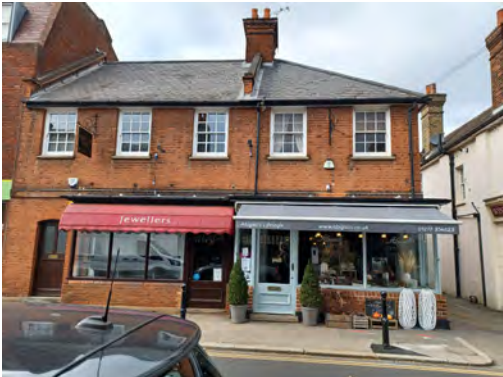
| BUILDING / STRUCTURE ELEMENT | BRIEF DESCRIPTION | BUILDING DESIGNATION | CONDITION (INCLUDING IF DISUSED) | CONTRIBUTION TO THE CA (CAA) | OBSERVATIONS / RECOMMENDATIONS | IMAGE |
|---|--|---|--|---|---|---|
| 42 and 44, Abigail's Lifestyle and Jewellers. | <ul style="list-style-type: none">• A range of two shops, one of three bays and one of two bays.• Red brick English bond.• A slate roof hipped at the north-east.• The first floor has five horned sash windows of 6+6 lights.• A glazed shopfront extension which covers four of the five bays springs from below a mid-height stringcourse of burnt bricks.• No.42's shopfront extends slightly further into the street.• Both have red brick plinths.• The first bay (No.44) has a timber three panel door partially glazed. | None | | 4 | <p>Remove redundant steel supports to prevent damage to the brickwork.</p> <p>Remove redundant alarm boxes.</p> | |

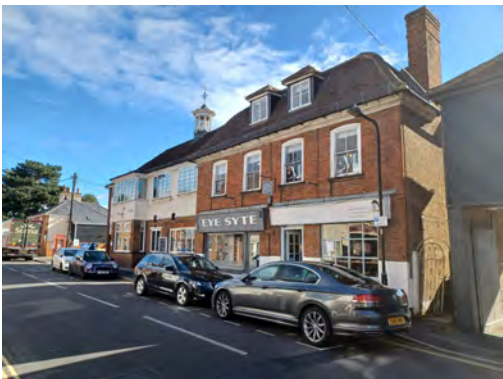
| BUILDING / STRUCTURE ELEMENT | BRIEF DESCRIPTION | BUILDING DESIGNATION | CONDITION (INCLUDING IF DISUSED) | CONTRIBUTION TO THE CA (CAA) | OBSERVATIONS / RECOMMENDATIONS | IMAGE |
|---|--|---|--|---|---|---|
| 9 and 11, Woodrange House. Ey Syte and Abigail's | <ul style="list-style-type: none">• Former house now two shops.• Eighteenth century, extended nineteenth and twentieth centuries.• Red brick Flemish bond, the upper floors to the rear, weatherboarded.• Two-storeys with two attic dormers.• Hipped roof of red clay tiles.• Moulded wooden eaves cornice which partially extends around each turn.• Each shop has a pair of first floor windows and a partially glazed door and large shop window – the right one of 12 lights. | Grade II | | 4 | <p>Repaint joinery.</p> <p>Remove redundant cables and refix and paint the remainder.</p> | |

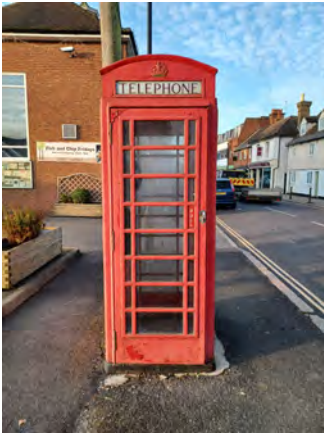
| BUILDING / STRUCTURE ELEMENT | BRIEF DESCRIPTION | BUILDING DESIGNATION | CONDITION (INCLUDING IF DISUSED) | CONTRIBUTION TO THE CA (CAA) | OBSERVATIONS / RECOMMENDATIONS | IMAGE |
|---|---|---|--|---|---|---|
| Telephone Box | <ul style="list-style-type: none">Type K6 as designed by Sir Giles Gilbert-Scott in 1935.Cast Iron | Grade II | | 5 | Repaint metalwork and clean glass and signs. | |

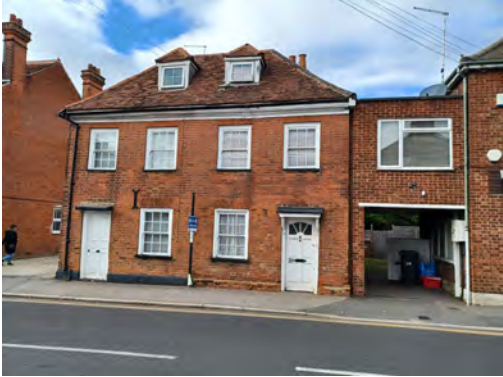
| BUILDING / STRUCTURE ELEMENT | BRIEF DESCRIPTION | BUILDING DESIGNATION | CONDITION (INCLUDING IF DISUSED) | CONTRIBUTION TO THE CA (CAA) | OBSERVATIONS / RECOMMENDATIONS | IMAGE |
|---|---|---|--|---|---|---|
| 28 and 30 | <ul style="list-style-type: none">Pair of attached cottages.Eighteenth century, extended in nineteenth and twentieth centuries.Red brick Flemish bond roofed with red clay tiles.Two-storeys with a pair of attic dormers.Each cottage has on the ground floor one twentieth century sash of 6+6 lights and on the first floor two similar sashes, all with flat brick arches and a casement in a hipped dormer.Wooden dentilled eaves cornice on the main hipped roof.Two-storey extensions to the rear, the lower floor of brick Flemish bond, the upper floors clad in white timber weatherboarding. | Grade II | | 5 | Secure loose wiring. Remove aerial if redundant. | |

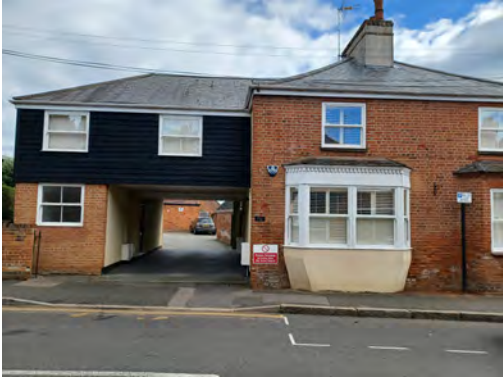
| BUILDING / STRUCTURE ELEMENT | BRIEF DESCRIPTION | BUILDING DESIGNATION | CONDITION (INCLUDING IF DISUSED) | CONTRIBUTION TO THE CA (CAA) | OBSERVATIONS / RECOMMENDATIONS | IMAGE |
|---|---|---|--|---|--|---|
| 3 and 5 | <ul style="list-style-type: none">Probably nineteenth century.Appears to be a detached two-storey house of brick with a hipped roof of slate and central stack.The street elevation is of red brick English bond with two ground floor bay windows. With horned sashes, with slate roofs and dentiled cornice.The left appears to be timber and rendering, the right of brick.The building has a twentieth century lean-to extension on the south-west, with a skylight.The north-east has a two-storey black weatherboarded range that incorporates a covered driveway with access through to the rear, the lower parts of brick and plaster, the upper part black timber weatherboarded. | None | | 4 | <p>Remove aerials if redundant.</p> <p>Remove satellite dish.</p> | |

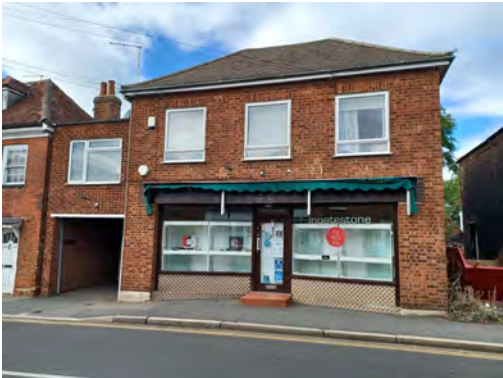
| BUILDING / STRUCTURE ELEMENT | BRIEF DESCRIPTION | BUILDING DESIGNATION | CONDITION (INCLUDING IF DISUSED) | CONTRIBUTION TO THE CA (CAA) | OBSERVATIONS / RECOMMENDATIONS | IMAGE |
|---|---|---|--|---|--|---|
| 26, Ingatestone Jewellers | <ul style="list-style-type: none">Twentieth century two-storey red brick stretch bond shop with hipped roof of plain tiles.Three uPVC upper storey windows.Large, recessed shop front with mosaic plinth, two large windows either side of a glazed door under a large awning.First floor extension over a covered driveway to the south-west in red brick stretcher bond. | None | | 3 | <p>Fix loose wiring.</p> | |

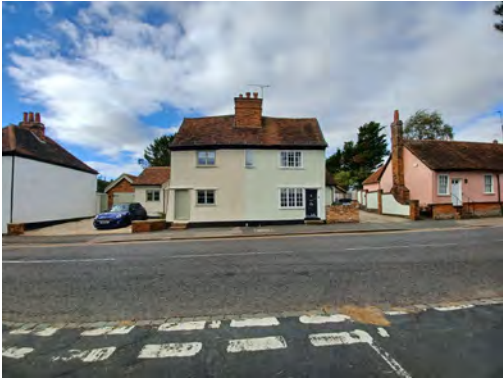
| BUILDING / STRUCTURE ELEMENT | BRIEF DESCRIPTION | BUILDING DESIGNATION | CONDITION (INCLUDING IF DISUSED) | CONTRIBUTION TO THE CA (CAA) | OBSERVATIONS / RECOMMENDATIONS | IMAGE |
|---|---|---|--|---|---|---|
| 18 and 20 | <ul style="list-style-type: none">Formerly one house now two.Late seventeenth century altered and extended in nineteenth and twentieth centuries.Timber-framed, roughcast rendered, roofed with handmade red clay tiles.Central red brick stack.Two-storeys with entrances at either ends of the south-east elevation.Twentieth century single and two-torey extensions to the sides and rear of the building, (south-west weatherboarded with gabled porch and red brick garage) and red brick driveway/ enclosure walls. | Grade II | | 5 | Remove aerial if redundant. | |

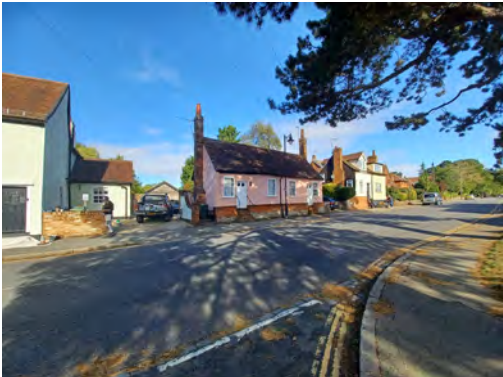
| BUILDING / STRUCTURE ELEMENT | BRIEF DESCRIPTION | BUILDING DESIGNATION | CONDITION (INCLUDING IF DISUSED) | CONTRIBUTION TO THE CA (CAA) | OBSERVATIONS / RECOMMENDATIONS | IMAGE |
|---|---|---|--|---|---|---|
| 14 and 16 | <ul style="list-style-type: none">Pair of attached cottages.Late eighteenth century altered in twentieth century.Timber-framed plastered and partially weatherboarded.Roofed in red clay tiles.A brick chimney at either gable end.One-storey with twentieth century sashes of 6+6 lights and six panel timber doors with top two glazed, three steps above street level with wrought iron railings.Battered plinth of red brick Flemish bond about one metre high. | Grade II | | 5 | Remove aerials if redundant. | |

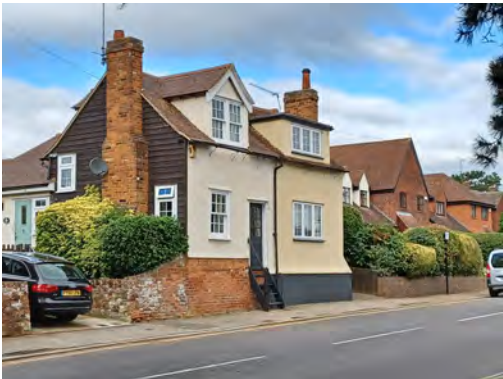
| BUILDING / STRUCTURE ELEMENT | BRIEF DESCRIPTION | BUILDING DESIGNATION | CONDITION (INCLUDING IF DISUSED) | CONTRIBUTION TO THE CA (CAA) | OBSERVATIONS / RECOMMENDATIONS | IMAGE |
|---|---|---|--|---|---|---|
| 10 and 12 | <ul style="list-style-type: none">Pair of attached cottages.Single-storey with two attic dormers, the left one gabled. Probably timber-framed, brick infill and plastered.High brick Flemish bond plinth exposed on No.12 with timber steps and rail rising to door.Single-storey extensions to the rear.South-west elevation partially weatherboarded.Driveway wall of red brick Flemish bond.Roofed in plain tiles. | None | | 5 | Remove aerial if redundant. Repoint garden wall. | |

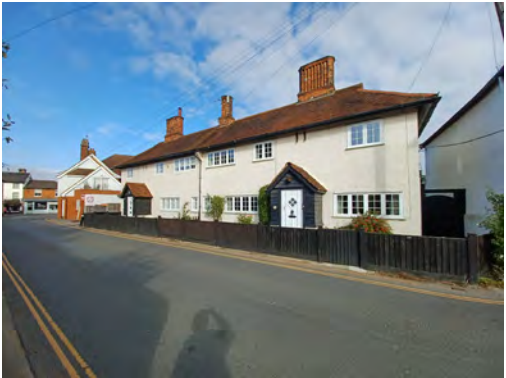
| BUILDING / STRUCTURE ELEMENT | BRIEF DESCRIPTION | BUILDING DESIGNATION | CONDITION (INCLUDING IF DISUSED) | CONTRIBUTION TO THE CA (CAA) | OBSERVATIONS / RECOMMENDATIONS | IMAGE |
|--|--|---|--|---|--|---|
| 2 and 3 | <ul style="list-style-type: none">Semi-detached two-storey cottages of painted brick, hipped roof of red clay tiles and three central decorative brick stacks along with a pair of black timber weatherboarded porches.Each with two ground floor windows of 24 lights and relieving arches.A pair of small loops on the first floor.Two narrow arched lights (or loops) either side of chimney stack.Enclosed by c.8ft high red brick Flemish bond wall with slight arch over timber gate.To the south a wide red brick garage with clack timber door and rendered gable end. With white weatherboard and gabled dovecote (?), roofed in red clay tiles. | None | Good | 4 | Remove aerial if redundant. | |

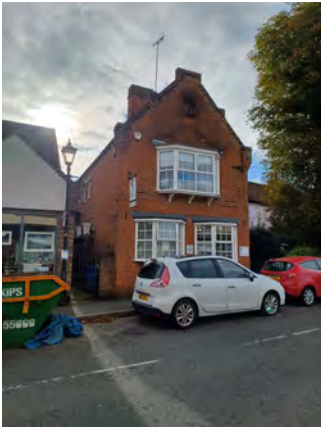
| BUILDING / STRUCTURE ELEMENT | BRIEF DESCRIPTION | BUILDING DESIGNATION | CONDITION (INCLUDING IF DISUSED) | CONTRIBUTION TO THE CA (CAA) | OBSERVATIONS / RECOMMENDATIONS | IMAGE |
|---|--|---|--|---|---|---|
| 5, Dentist | <ul style="list-style-type: none">Two-storey red brick Flemish bond gable ended barn-like structure perpendicular to the street with decorative brick cornice and corbeling and vent or loop in the gable.First floor oriel window of 40 lights, two oriels at ground of 28.Plain tile roof. | None | Good | 4 | Remove aerial if redundant. | |

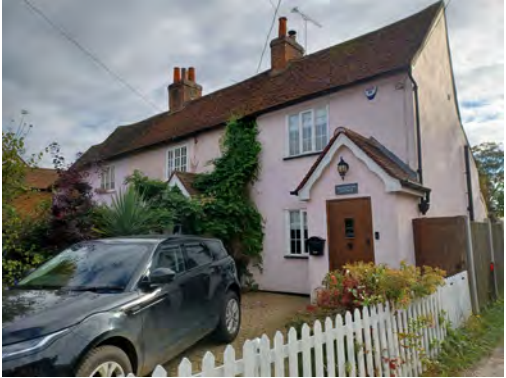
| BUILDING / STRUCTURE ELEMENT | BRIEF DESCRIPTION | BUILDING DESIGNATION | CONDITION (INCLUDING IF DISUSED) | CONTRIBUTION TO THE CA (CAA) | OBSERVATIONS / RECOMMENDATIONS | IMAGE |
|---|--|---|--|---|---|---|
| 7, 9 and 11 | <ul style="list-style-type: none">Row of three, two-storey houses.Probably formerly one house.Probably timber frame and brick now plastered.Roofed with clay tiles with two central brick stacks.Each with gabled and tiled porch. | None | Good | 4 | Remove aerial if redundant. | |

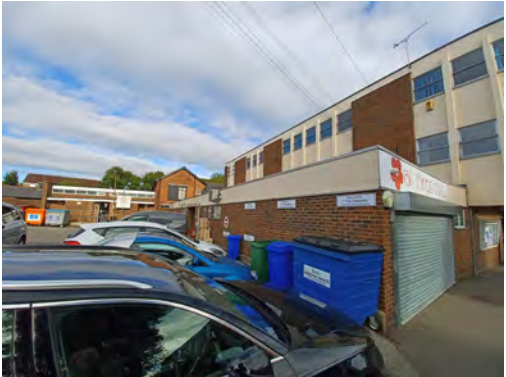
| BUILDING / STRUCTURE ELEMENT | BRIEF DESCRIPTION | BUILDING DESIGNATION | CONDITION (INCLUDING IF DISUSED) | CONTRIBUTION TO THE CA (CAA) | OBSERVATIONS / RECOMMENDATIONS | IMAGE |
|---|--|---|--|---|---|---|
| 2, All Things Cute | <ul style="list-style-type: none">Shop. Rear single-storey extension of main market building.Red brick stretcher bond.One, two-light window to the right of metallic shop cover. | None | | Not included in CAA 2 | Poor quality building. | |

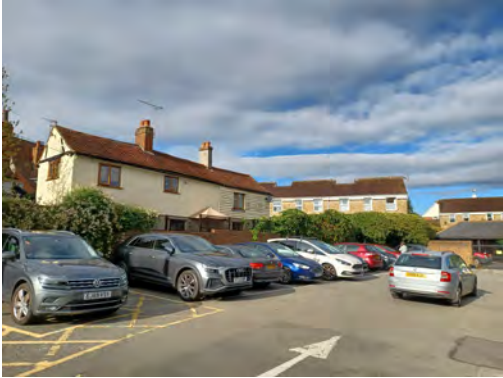
| BUILDING / STRUCTURE ELEMENT | BRIEF DESCRIPTION | BUILDING DESIGNATION | CONDITION (INCLUDING IF DISUSED) | CONTRIBUTION TO THE CA (CAA) | OBSERVATIONS / RECOMMENDATIONS | IMAGE |
|---|--|---|--|---|---|---|
| 16 | <ul style="list-style-type: none">Two-storeys, long, barn-like structure.Probably timber framed, now plastered and partially weatherboarded at the eastern end.Three, two-light windows visible on the upper storey from the car park.Some timber posts visible in the attic level from the road. | None | Good | 4 | Remove aerial if redundant. | |

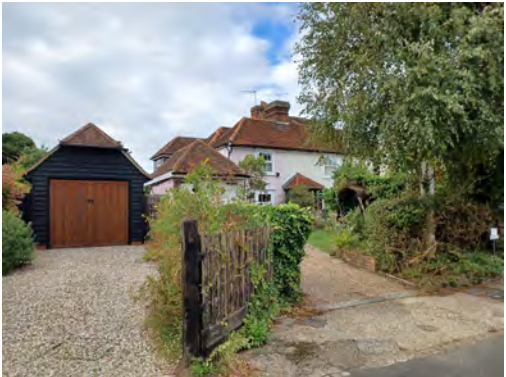
| BUILDING / STRUCTURE ELEMENT | BRIEF DESCRIPTION | BUILDING DESIGNATION | CONDITION (INCLUDING IF DISUSED) | CONTRIBUTION TO THE CA (CAA) | OBSERVATIONS / RECOMMENDATIONS | IMAGE |
|---|--|---|--|---|--|---|
| 14 and 16 | <ul style="list-style-type: none">A pair of semi-detached brick and plastered houses, roofed in red plain tiles with like garages alongside.Set being trees and bushes. | None | Good | 4 | Remove aerial if redundant. | |

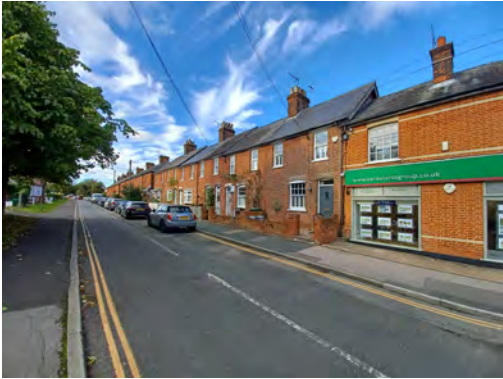
| BUILDING / STRUCTURE ELEMENT | BRIEF DESCRIPTION | BUILDING DESIGNATION | CONDITION (INCLUDING IF DISUSED) | CONTRIBUTION TO THE CA (CAA) | OBSERVATIONS / RECOMMENDATIONS | IMAGE |
|---|--|---|--|---|--|---|
| 1-6 | <ul style="list-style-type: none">Range of six, two-storey terraced houses each with two first floor sash arched windows, one at ground floor with door and fanlight.Red brick Flemish bond roofed in slate with three central stacks.Gables of second and third pair and continually slightly higher roofs. | None | Good | 4 | <p>Remove aerials if redundant.</p> <p>Remove redundant services and tidy remainder.</p> <p>Reinstate missing boundary demarcations.</p> | |

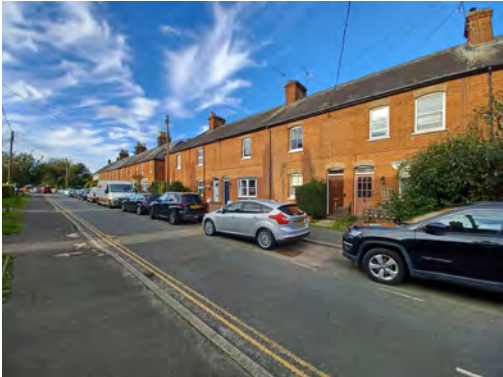
| BUILDING / STRUCTURE ELEMENT | BRIEF DESCRIPTION | BUILDING DESIGNATION | CONDITION (INCLUDING IF DISUSED) | CONTRIBUTION TO THE CA (CAA) | OBSERVATIONS / RECOMMENDATIONS | IMAGE |
|---|--|---|--|---|--|---|
| 7-12 | <ul style="list-style-type: none">Range of six, two-storey terraced houses each with two first floor sash or uPVC arched windows, one at ground floor with door and fanlight.Red brick Flemish bond roofed in slate with six central stacks. | None | Good | 4 | <p>Remove aerials if redundant.</p> <p>Remove redundant services and tidy remainder.</p> <p>Reinstate missing boundary demarcations.</p> | |

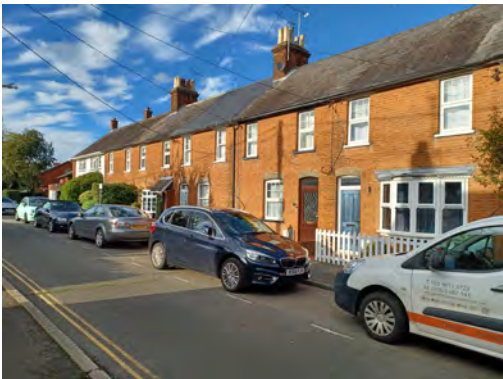
| BUILDING / STRUCTURE ELEMENT | BRIEF DESCRIPTION | BUILDING DESIGNATION | CONDITION (INCLUDING IF DISUSED) | CONTRIBUTION TO THE CA (CAA) | OBSERVATIONS / RECOMMENDATIONS | IMAGE |
|---|--|---|--|---|--|---|
| 13-19 | <ul style="list-style-type: none">Range of six, two-storey terraced houses each with two first floor sash or uPVC arched windows, one at ground floor with door and fanlight.Red brick Flemish bond roofed in slate with six central stacks.No.19 is twentieth century added extension and is wider than others.Brick stretcher bond, upper storey is plastered.Brick pair of garages to the left. | None | Good | 4 | <p>Remove aerials if redundant.</p> <p>Remove redundant services and tidy remainder.</p> <p>Reinstate missing boundary demarcations.</p> | |

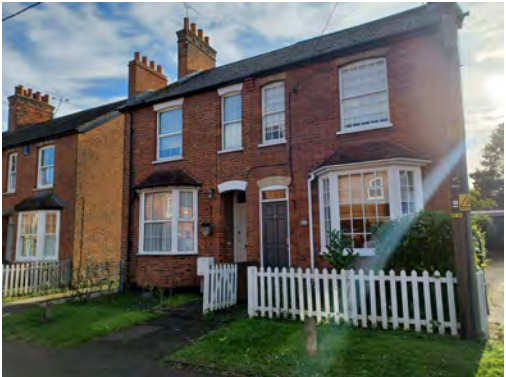
| BUILDING / STRUCTURE ELEMENT | BRIEF DESCRIPTION | BUILDING DESIGNATION | CONDITION (INCLUDING IF DISUSED) | CONTRIBUTION TO THE CA (CAA) | OBSERVATIONS / RECOMMENDATIONS | IMAGE |
|---|--|---|--|---|--|---|
| 46 and 47 | <ul style="list-style-type: none">Semi-detached two-storey house of red brick Flemish bond and slate roof with stacks at either end.Ground floor bay windows roofed in plain red tiles.Two, six panelled doors and fan lights.Two arched windows each on first floor. | None | Good | 4 | <p>Remove aerials if redundant.</p> <p>Remove redundant services and tidy remainder.</p> <p>Reinstate missing boundary demarcations.</p> | |

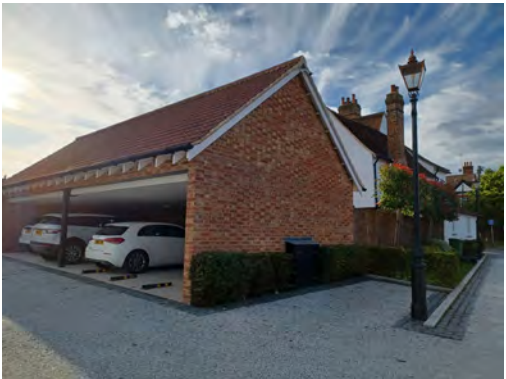
| BUILDING / STRUCTURE ELEMENT | BRIEF DESCRIPTION | BUILDING DESIGNATION | CONDITION (INCLUDING IF DISUSED) | CONTRIBUTION TO THE CA (CAA) | OBSERVATIONS / RECOMMENDATIONS | IMAGE |
|---|--|---|--|---|---|---|
| Garage | <ul style="list-style-type: none">Twenty-first century brick Flemish bond with room for four car ports.Roofed in pan tiles. | None | Good | Not included in CAA 3 | | |

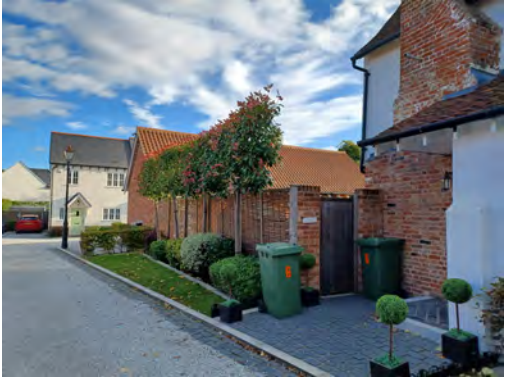
| BUILDING / STRUCTURE ELEMENT | BRIEF DESCRIPTION | BUILDING DESIGNATION | CONDITION (INCLUDING IF DISUSED) | CONTRIBUTION TO THE CA (CAA) | OBSERVATIONS / RECOMMENDATIONS | IMAGE |
|---|--|---|--|---|---|--|
| 3-5 | | None | Good | Not included in CAA 3 | | |

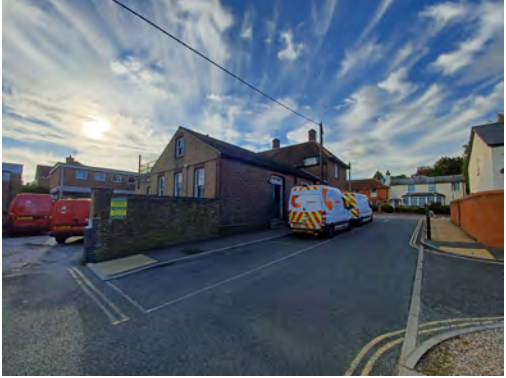
| BUILDING / STRUCTURE ELEMENT | BRIEF DESCRIPTION | BUILDING DESIGNATION | CONDITION (INCLUDING IF DISUSED) | CONTRIBUTION TO THE CA (CAA) | OBSERVATIONS / RECOMMENDATIONS | IMAGE |
|---|--|---|--|---|---|--|
| Rear of Post Office | <ul style="list-style-type: none">Long, single-storey range with attic, red brick Flemish bond.Timber double door with fanlight of six.Runs to yellow brick wall and gateway to small car park. | None | Good | 4 | Repaint side doors. | |

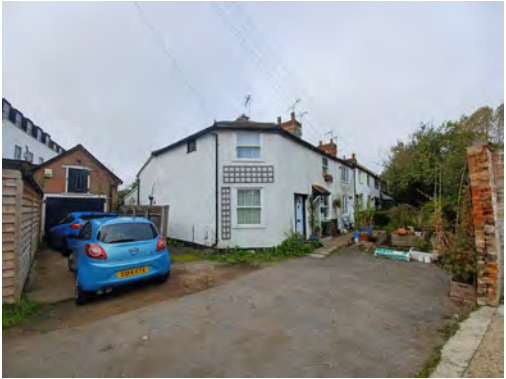
| BUILDING / STRUCTURE ELEMENT | BRIEF DESCRIPTION | BUILDING DESIGNATION | CONDITION (INCLUDING IF DISUSED) | CONTRIBUTION TO THE CA (CAA) | OBSERVATIONS / RECOMMENDATIONS | IMAGE |
|---|---|---|--|---|---|---|
| I-7 | <ul style="list-style-type: none">A row of seven terraced houses, two-storeys plastered, pebble dashed and painted.One window on first and second floor each.No.1 has canted corner with an upper and lower window. | None | Fairly Good | 4 | | |

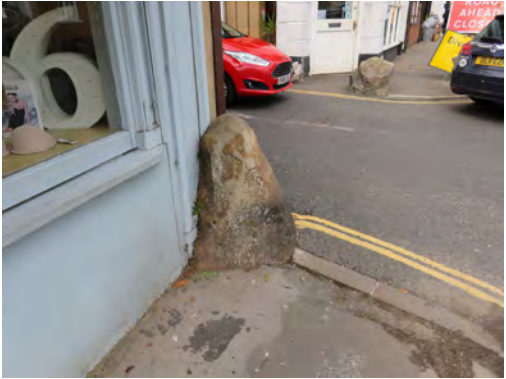
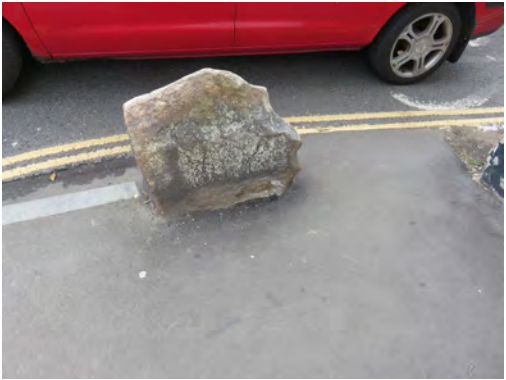
| BUILDING / STRUCTURE ELEMENT | BRIEF DESCRIPTION | BUILDING DESIGNATION | CONDITION (INCLUDING IF DISUSED) | CONTRIBUTION TO THE CA (CAA) | OBSERVATIONS / RECOMMENDATIONS | IMAGE |
|---|---|---|--|---|---|---|
| Flanking stones | <ul style="list-style-type: none">Pair of sand stones flanking the entranceway to Fryerning Road from the High Street.Less than a metre tall. | Of local importance | Good | 5 | | |

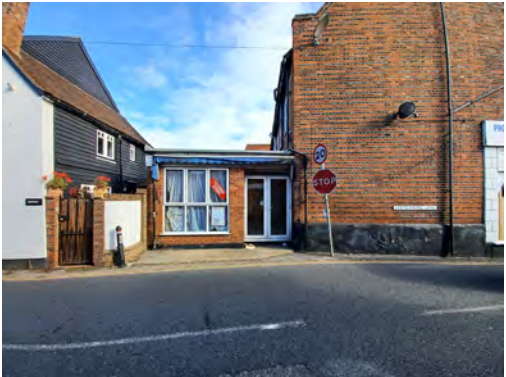
| BUILDING / STRUCTURE ELEMENT | BRIEF DESCRIPTION | BUILDING DESIGNATION | CONDITION (INCLUDING IF DISUSED) | CONTRIBUTION TO THE CA (CAA) | OBSERVATIONS / RECOMMENDATIONS | IMAGE |
|---|--|---|--|---|---|---|
| Rear of 64 and shop | <ul style="list-style-type: none">Single-storey red brick stretcher bond extension with large shop window of six uPVC lights and a uPVC double door. | None | Disused | 2 | Replace door and fenestration. | |

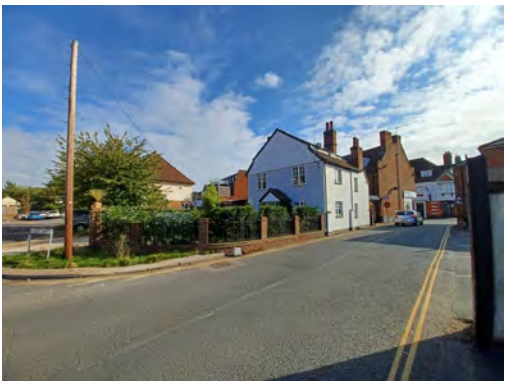
| BUILDING / STRUCTURE ELEMENT | BRIEF DESCRIPTION | BUILDING DESIGNATION | CONDITION (INCLUDING IF DISUSED) | CONTRIBUTION TO THE CA (CAA) | OBSERVATIONS / RECOMMENDATIONS | IMAGE |
|---|--|---|--|---|---|---|
| No.1 | <ul style="list-style-type: none">Two-storey plastered brick house with partial black and white timber weatherboarding roofed in red plain tiles.Gable ended porch.Cobblestone garden surrounded by brick wall and metal railings. | None | Good | 4 | | |
